CASA DE ADOBE HISTORIC STRUCTURE REPORT

DRAFT - APRIL 14, 2006

AUTRY NATIONAL CENTER'S SOUTHWEST MUSEUM OF THE AMERICAN INDIAN 234 Museum Drive Los Angeles, CA 90065

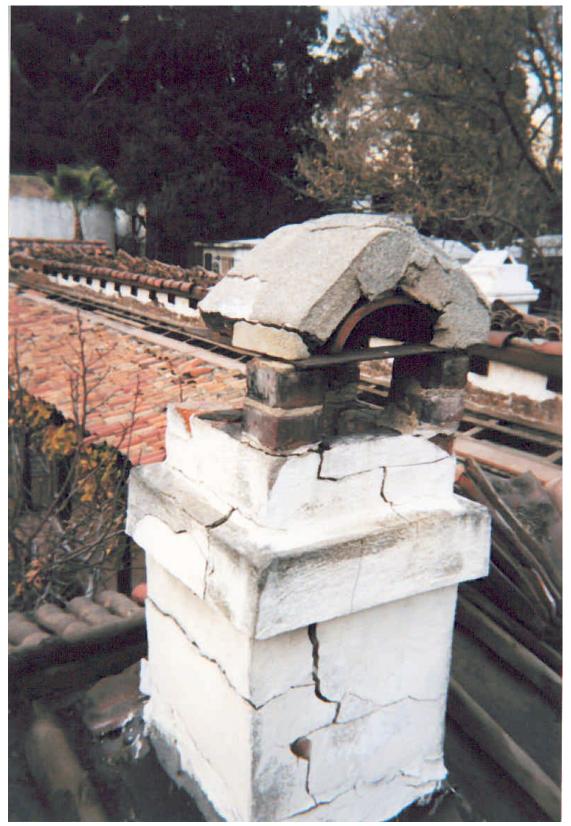
HP 25: Damage to the Kitchen chimney prior to reconstruction, 1998.

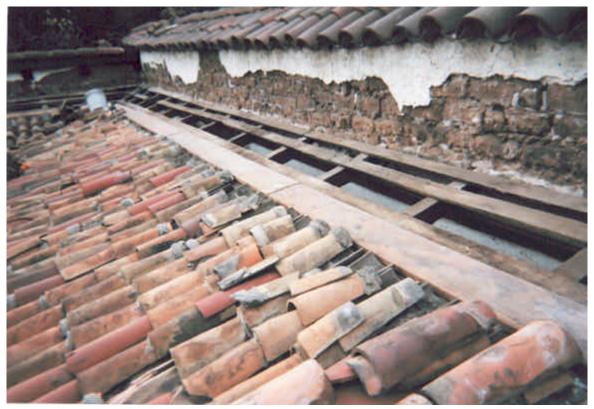
HP 27: Plaster damage and the existing tile that have been removed and drilled for seismic anchoring, 1998.

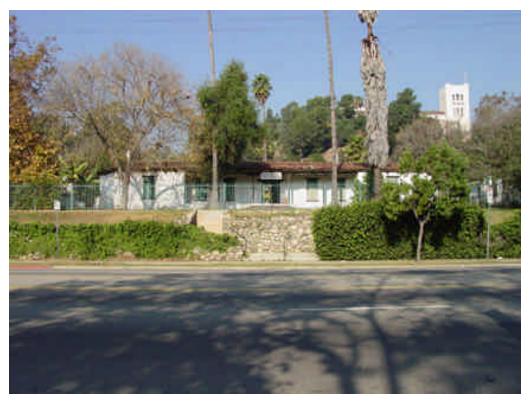
Photo 1: Casa de Adobe from Figueroa Street. Original rock studded retaining wall is partially covered by overgrown shrubs. 2005

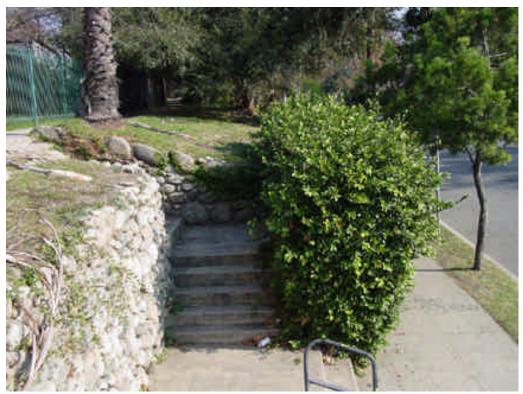
Photo 4: Overgrown shrub covering portions of the retaining wall. 2005

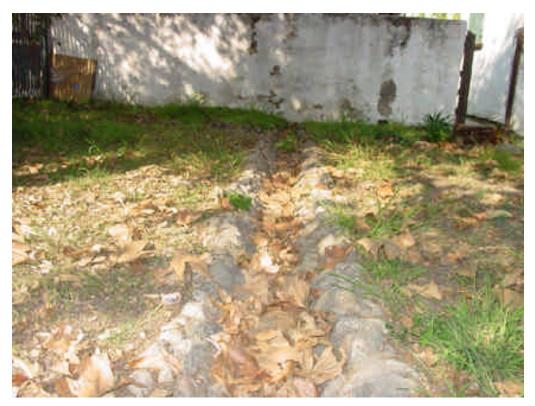
Photo 10: Site drainage at the southeast elevation needs to be cleared of all debris on a regular basis. 2005

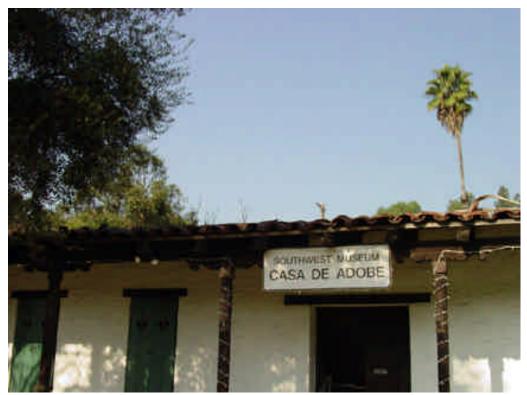
Photo 16: West façade showing signs of deterioration and dislocation of some roof tiles. 2005

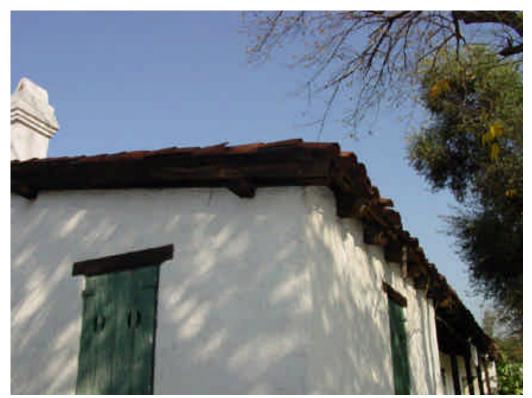
Photo 38: Dryrot along rafter tails at southeast corner. 2005

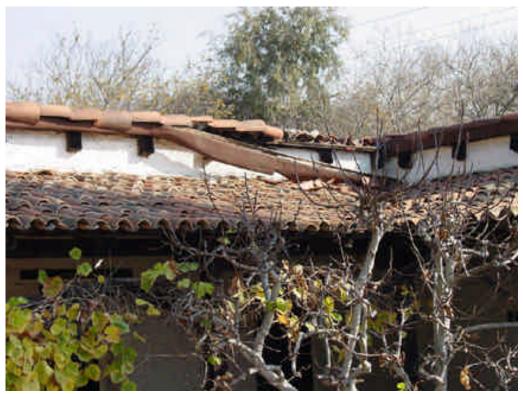
Photo 42: Damaged roofing material at northwest corner. 2005

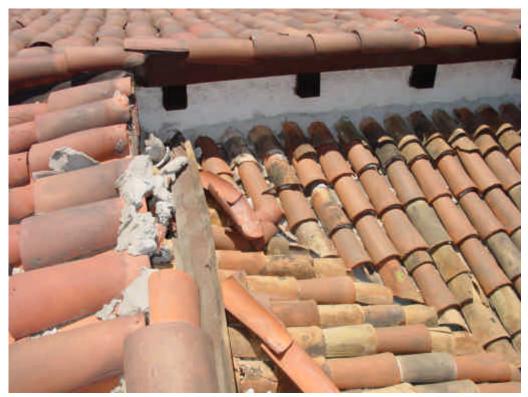
Photo 43: Northwest roof damage. 2005

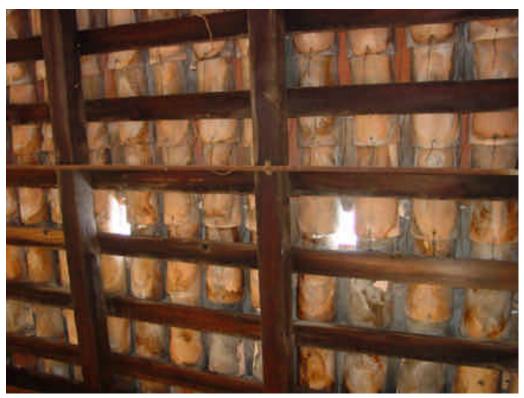
Photo 46: Missing roof tile at west porch. 2005

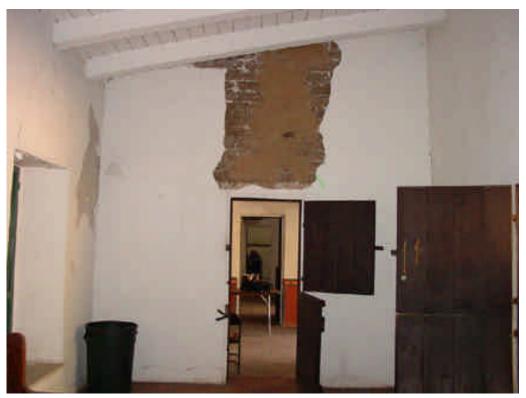
Photo 56: Looking south at Parlor showing Dutch doors and delaminated plaster with exposed adobe. 2005

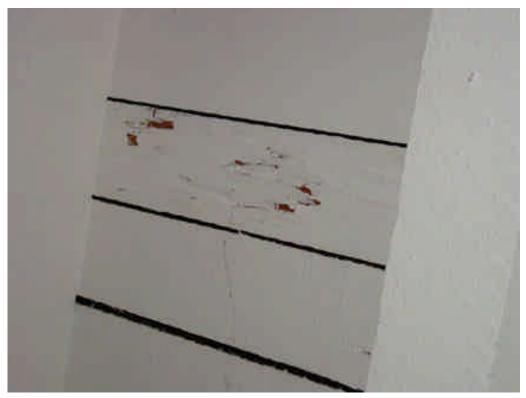
Photo 59: Dryrot at Dining Room ceiling. 2005

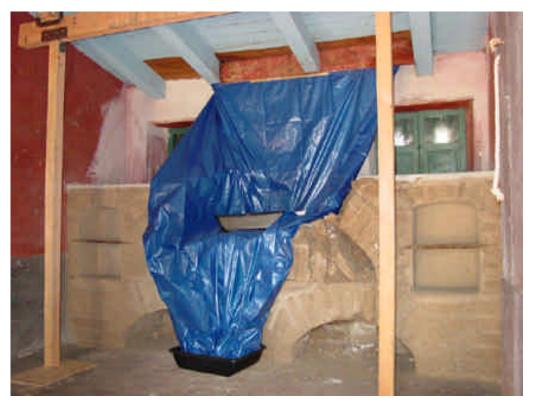
Photo 60: Damage at Kitchen caused by 2004 winter rains. 2005

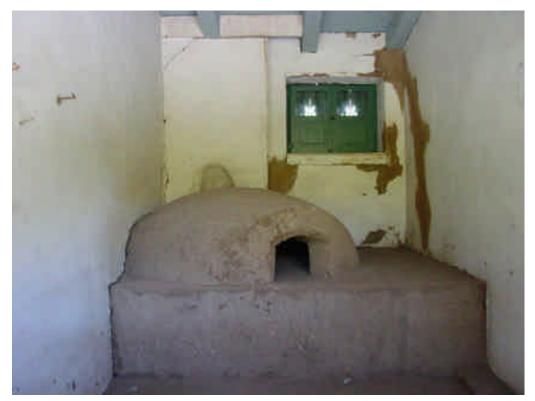
Photo 62: The Horno is unplastered. The plaster wall shows some damage at the northeast corner 2005

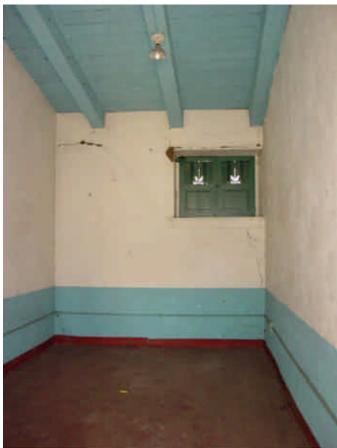
Photo 63: The Pantry currently contains nonhistoric light fixtures and exposed conduit. 2005

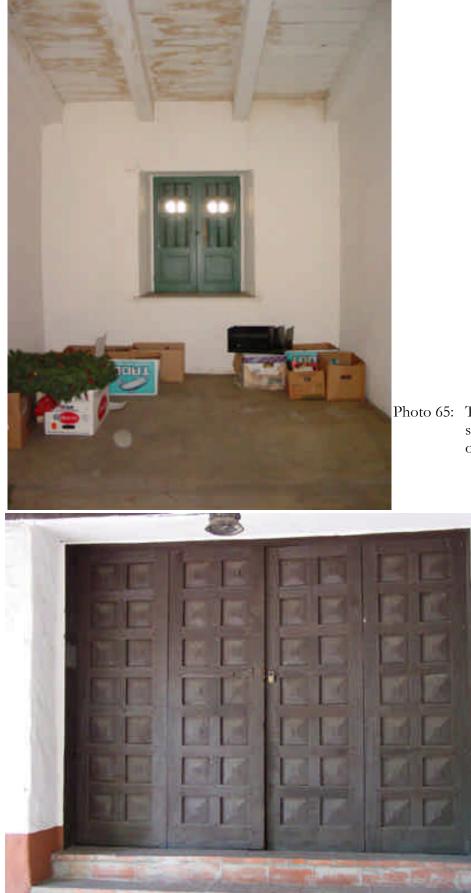
Photo 65: The Chaplain's Room shows some previous water damage on the ceiling. 2005

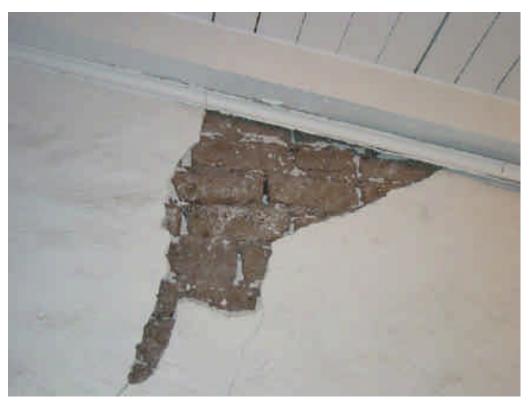
Photo 88: Delamination of plaster exposing adobe at Women's Restroom. 2005

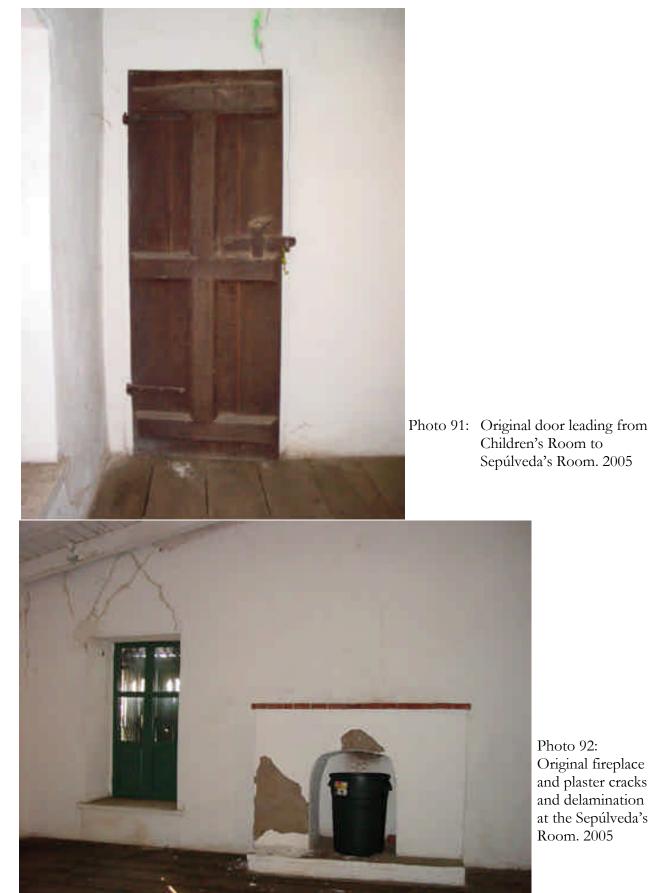
Photo 92: Original fireplace and plaster cracks and delamination at the Sepúlveda's Room. 2005

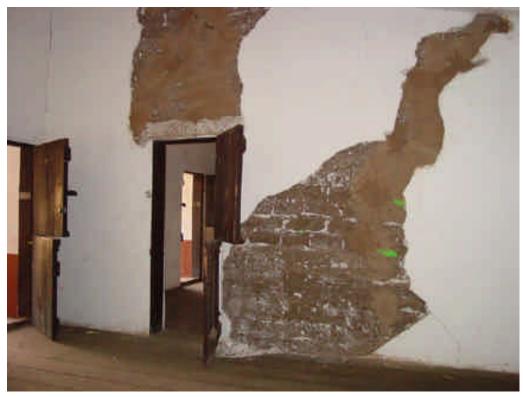
Photo 93: Sepúlveda Room looking north showing missing plaster and exposed adobe. This wall was stabilized using stitch anchoring. 2005

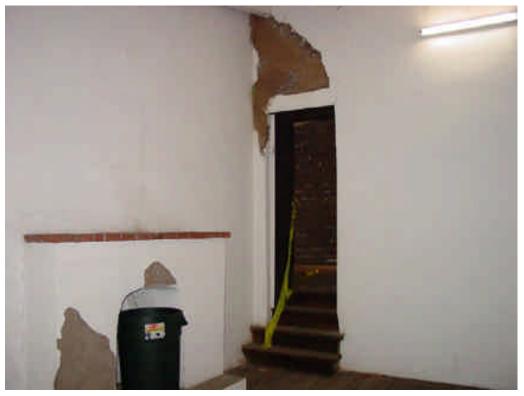
Photo 94: Doorway leading to children's room at Sepúlveda Room showing missing plaster and exposed adobe. 2005

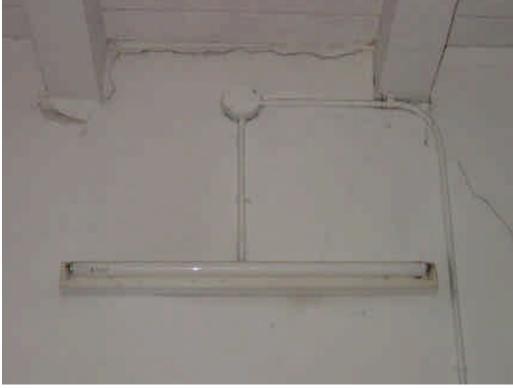
Photo 95: Non-historic fluorescent lighting at Pio Pico Room. 2005

There are also several non-historic fluorescent fixtures. These fixtures are non-contributing. They should be removed and/or replaced with period style fixtures.
