# Southwest Museum Rehabilitation Study

## Phase I Planning

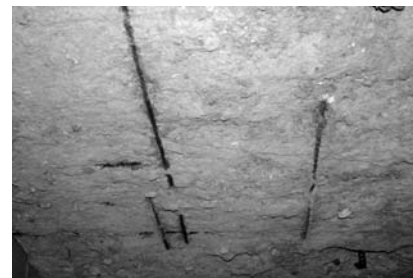
The historic buildings of the Southwest Museum Campus were found to be fairly sound. Exceptions are insufficient shear wall or other lateral load resistance in the east and south walls at the base of Caracol Tower and rusted reinforcing bars observed in the underside of the Museum Store slab.

**S001** - Rusted reinforcing bars below museum store

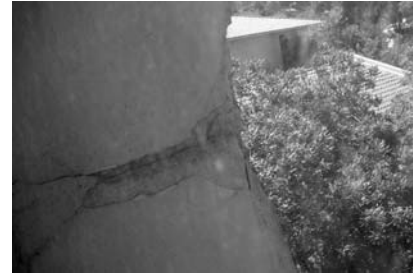
**S004** - Caracol Tower - crack at window jamb

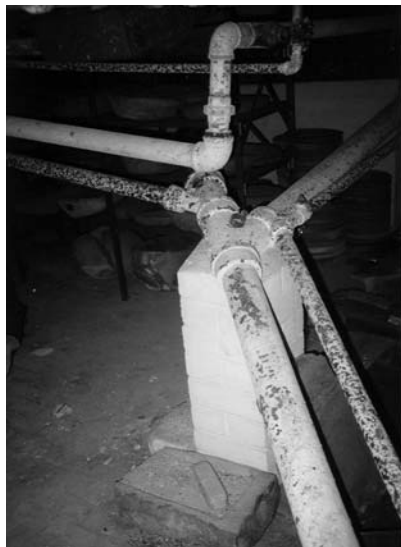
The domestic water piping is galvanized steel. Corrosion has occurred and it is recommended to re-pipe the building with copper. Problems with the site sewer lines have required several repairs.

**P001** - Corroded galvanized steel water pipe

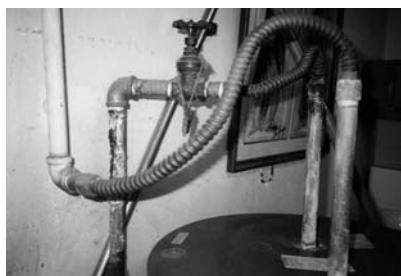
**P002** - Galvanized steel water pipe; signs of corrosion

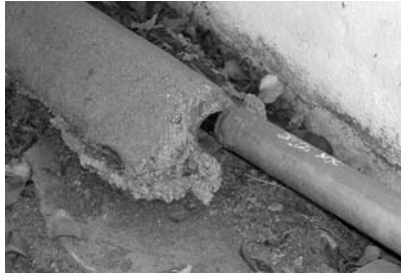
**E004** - Exterior power conduit exposed to moisture

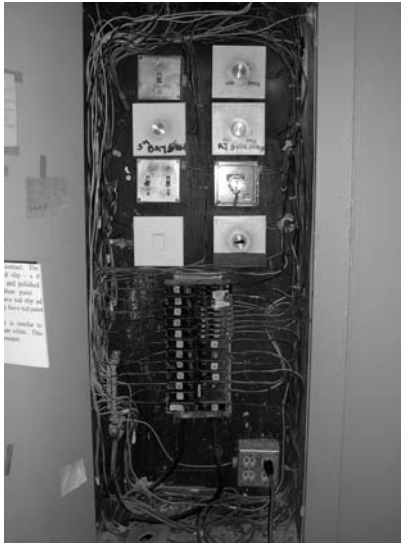
**E005** - Sprague Hall panel showing multiple code violations

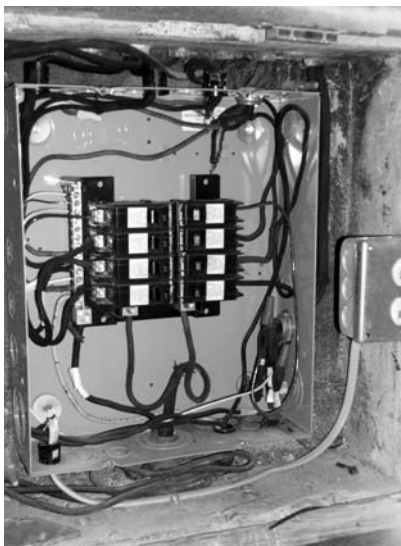
**E007** - Torrance Tower panel showing multiple code violations

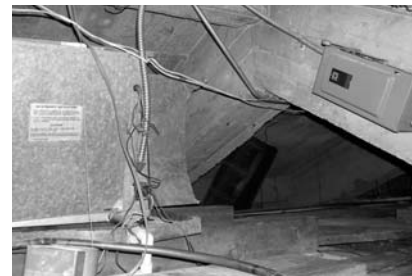
**E009** - Main Building attic, illegal wiring conditions

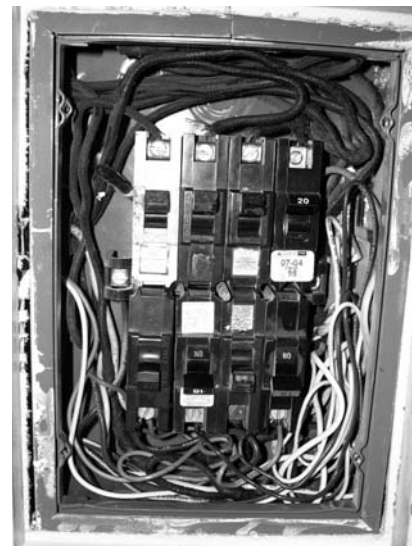
**E010** - Administration area panel showing multiple code violations

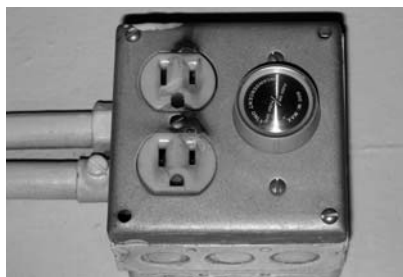
**E011** - Administration area; receptacle showing burn marks

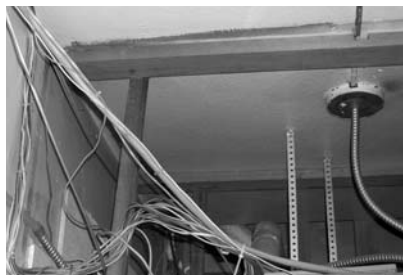
**E012** - Administration area; exposed, illegal wiring condition

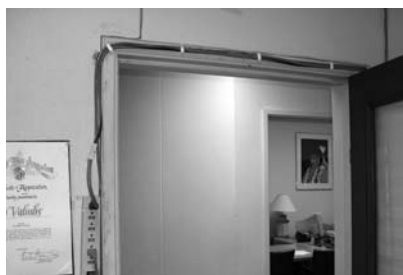
**E013** - Administration area; extension cord used for permanent wiring

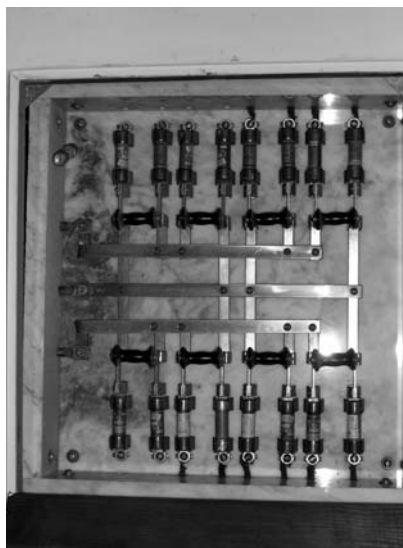
**E014** - Caracol Tower marble panel showing multiple code violations

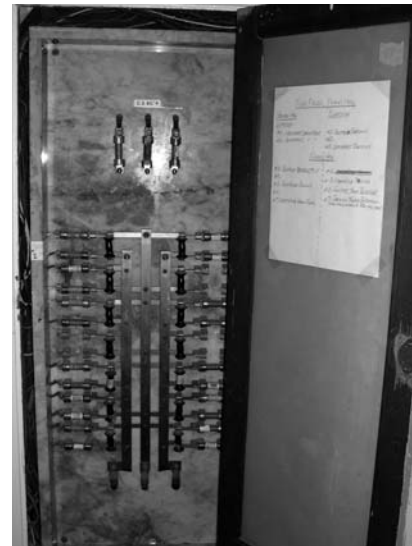
**E016** - Plains Hall- marble panel showing multiple code violations

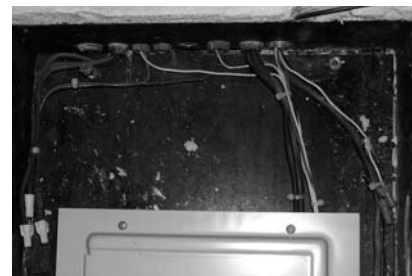
**E017** - Upper Southwest Hall panel showing multiple code violations

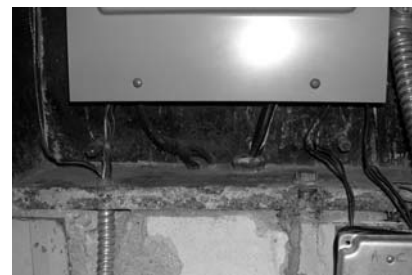
**E018** - Bottom of Upper Southwest Hall panel showing illegal switch in panel cavity

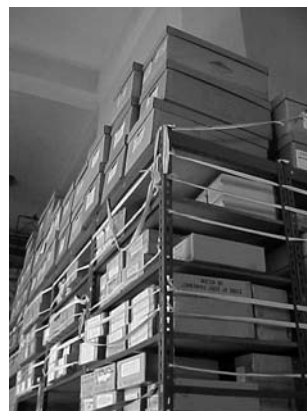
LS003 - High-piled storage in Caracol Tower
