DRAFT CASA DE ADOBE

REPORT UPDATE & REPORT

PREPARED FOR The City of Los Angeles

Casa De Adobe Report Update and Report

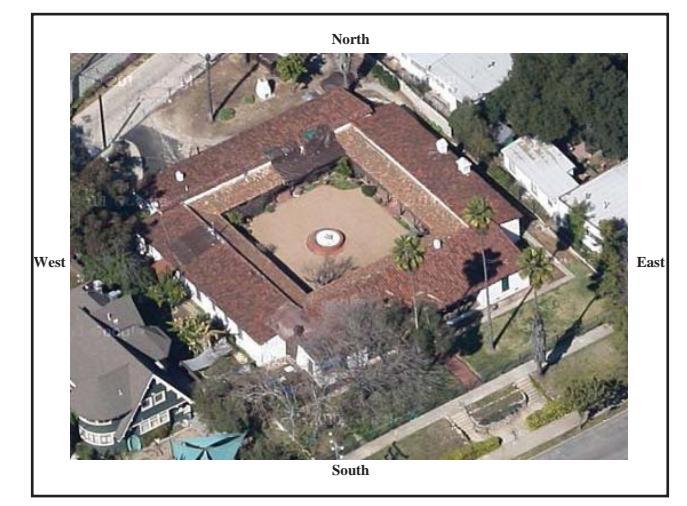
Figure 4.1: Casa de Adobe SOURCE: John A. Martin & Associates, Inc.

- 1. The overall building site is shown in photo 4.1.
- 2. The south entrance is shown in photo 4.2.
- 3. In various areas of interior and exterior walls, the plaster has deteriorated causing the adobe bricks to be exposed as shown in photo 4.3 of a portion of the south wall. The adequacy of the plaster and exposed adobe should be investigated to determine required repairs or replacements.

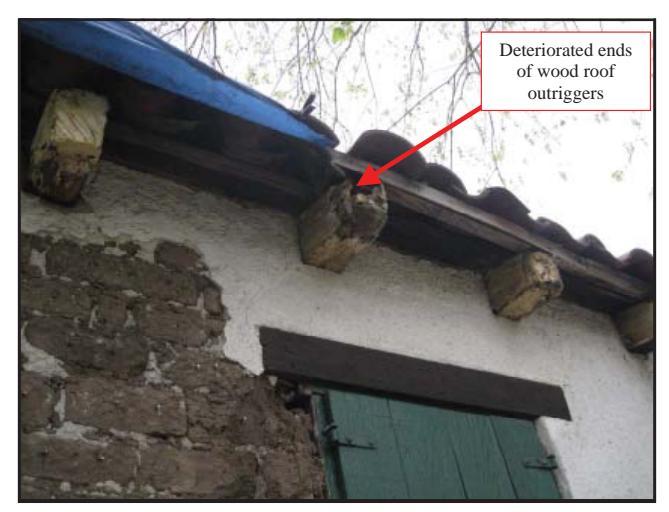
- 4. In various areas of the roof, the wood outriggers are deteriorated as shown in photos 4.3, 4.4, and 4.9. The adequacy of the wood outriggers should be investigated to determine required repairs or replacement.

Figure 4.4: Deteriorated Wood Outriggers SOURCE: John A. Martin & Associates, Inc.

Some Casa de Adobe roof wood outriggers require repair or placement.

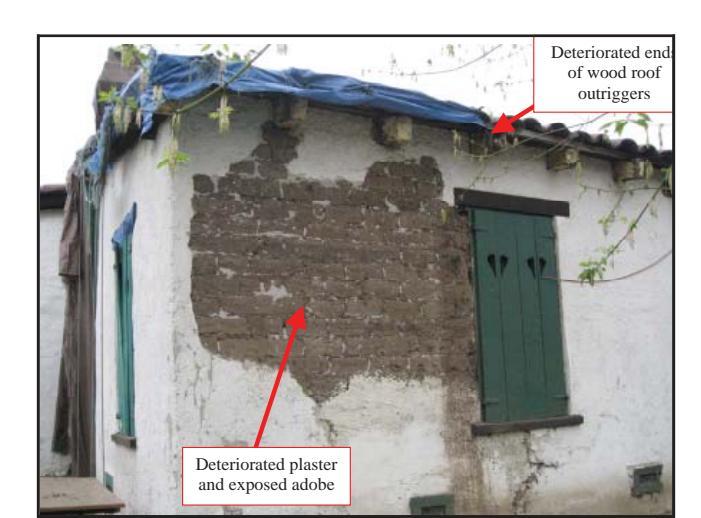
Figure 4.3: Deteriorated South Wall SOURCE: John A. Martin & Associates, Inc.

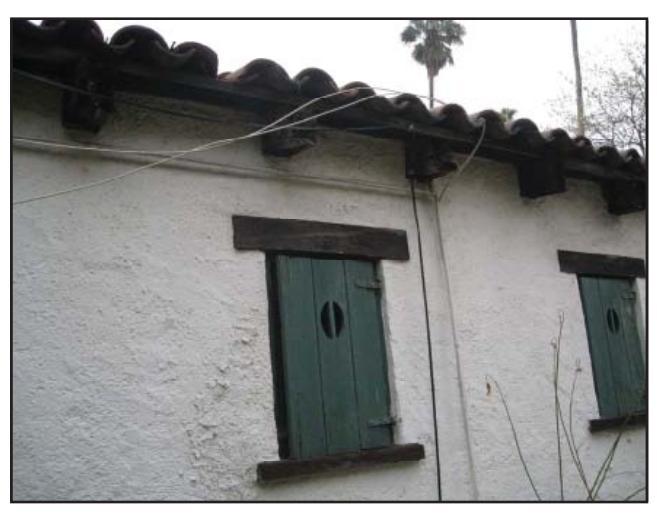
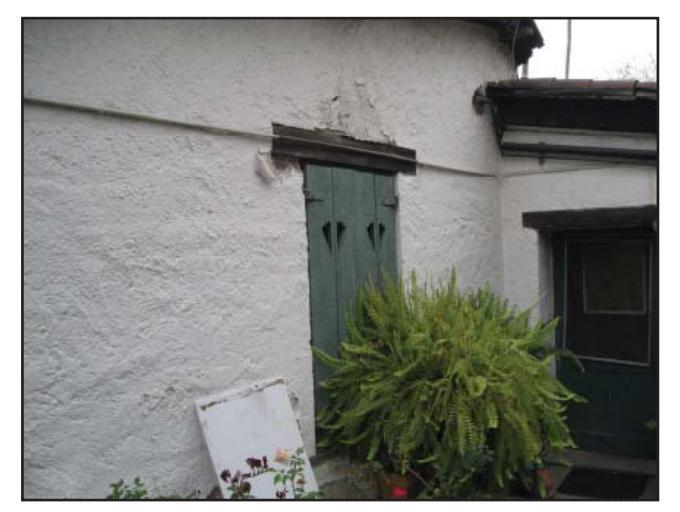
- 6. A portion of the west wall is shown in photos 4.6 and 4.7.
- 7. A portion of the north wall is shown in photo 4.8.

Figure 4.6: West wall SOURCE: John A. Martin & Associates, Inc.

Figure 4.7: West Wall SOURCE: John A. Martin & Associates, Inc.

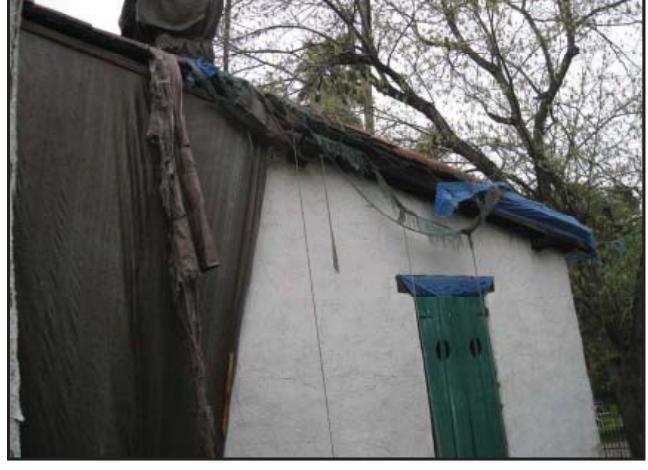
- 5. The existing roof may leak water as evidenced by the plastic protection shown in photo 4.5. The adequacy of the roofing should be investigated to determine required repairs or replacement.

Figure 4.5: Plastic protection at south end of west wall SOURCE: John A. Martin & Associates, Inc.

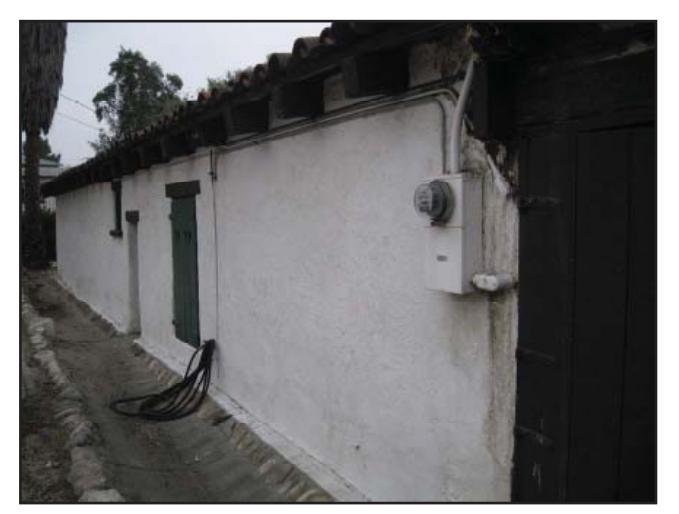
Figure 4.8: North Wall SOURCE: John A. Martin & Associates, Inc.

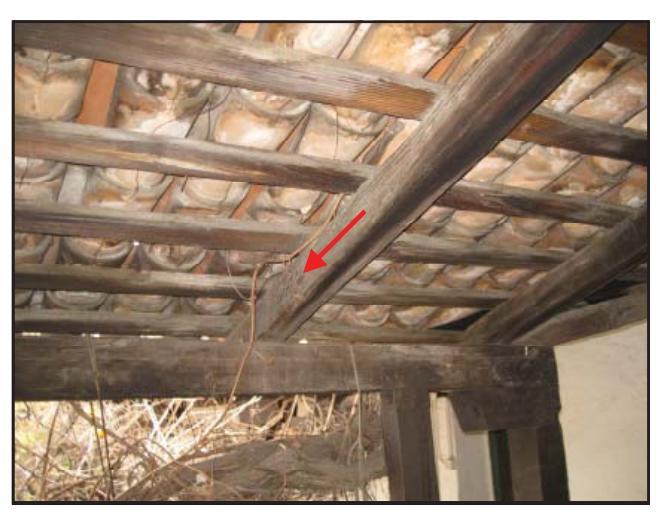
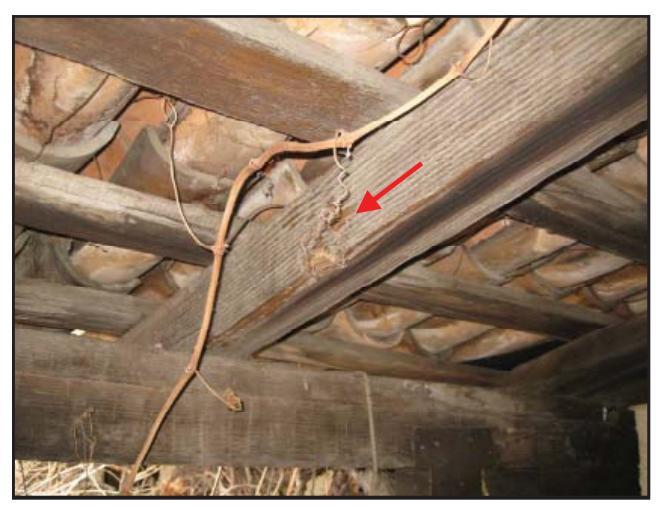
Figure 4.10: Deteriorated wood canopy roof supports SOURCE: John A. Martin & Associates, Inc.

Figure 4.11: Close-up of supports per Fig 4.10 SOURCE: John A. Martin & Associates, Inc.

- 8. The courtyard canopy roof framing has minimal structural supports with evidence of wood and clay tile deterioration as shown in photos 4.10 and 4.11. The wood framing for the canopy appears to require removal and replacement with adequate structural framing which will require the clay tile to be removed and replaced. The adequacy of the wood framing and clay tile should be investigated to validate the above structural framing replacement.

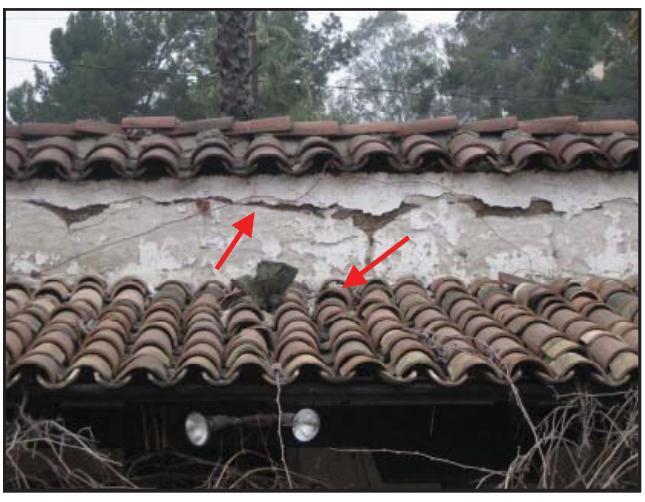
Figure 4.12: Broken plaster and clay tiles at east wall SOURCE: John A. Martin & Associates, Inc.

- 10. In various areas of the interior and exterior walls, the plaster has deteriorated causing the adobe to be exposed as shown in photos 4.12, 4.13, and 4.14. The adequacy of the clay tile should be investigated to determine required repairs or replacement.

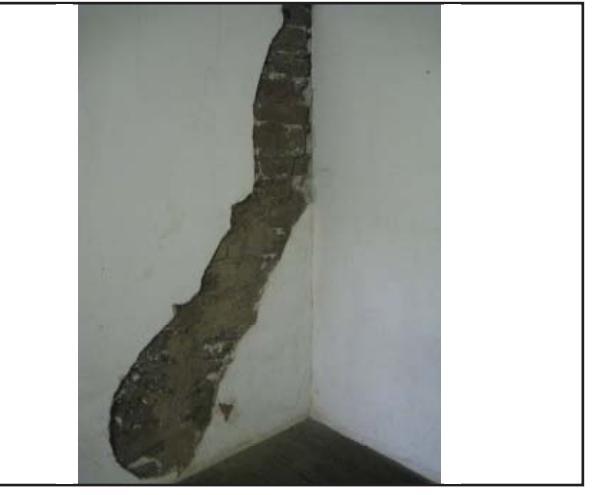
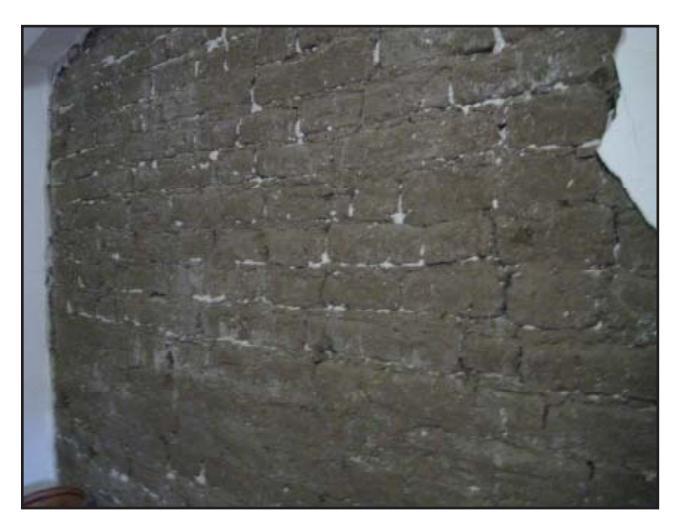
Figure 4.14: Interior wall with plaster removed SOURCE: John A. Martin & Associates, Inc.

Figure 4.13: Interior wall with plaster removed SOURCE: John A. Martin & Associates, Inc.

Some of the adobe has been exposed and unprotected and may require repairs or replacement.

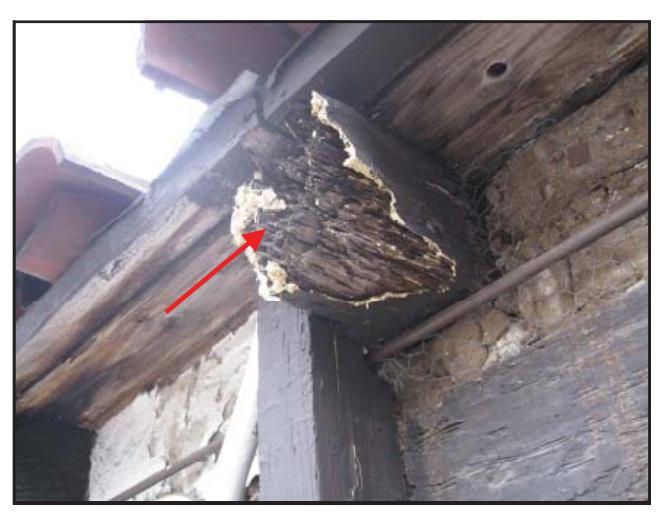
Figure 4.9: Close-up of deteriorated wood outrigger SOURCE: John A. Martin & Associates, Inc.

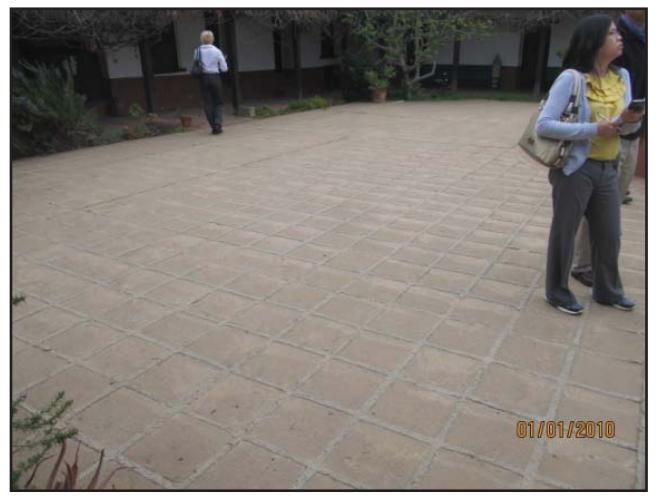
Grades within the courtyard flow from the northwesterly edge to the southwesterly edge. Slope from northwest to southwest seem to be consistent except for minor paving uplift, for example, at the northerly corner of the courtyard where grades are jagged. Figure 5.3 illustrates damaged pavers. The northeast, northwest, and southwest covered walkways also follow the grades of the courtyard so that they slope from northwest to southwest.

Figure 5.3: Unevenness of pavers and damage throughout SOURCE: VCA Engineers, Inc.

- New grades for the courtyard area that will recreate the existing swale action further away from the interior southeast face of the existing building. Compacted base should also be provided to reduce the loosening of pavers.

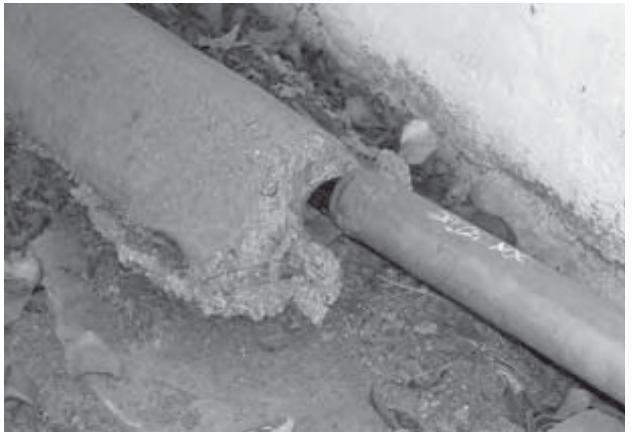
Figure 5.17:Exterior power conduit exposed to moisture SOURCE: Levin & Associates, 2003
