DRAFT CASA DE ADOBE

REPORT UPDATE & REPORT

PREPARED FOR The City of Los Angeles

Casa De Adobe Report Update and Report

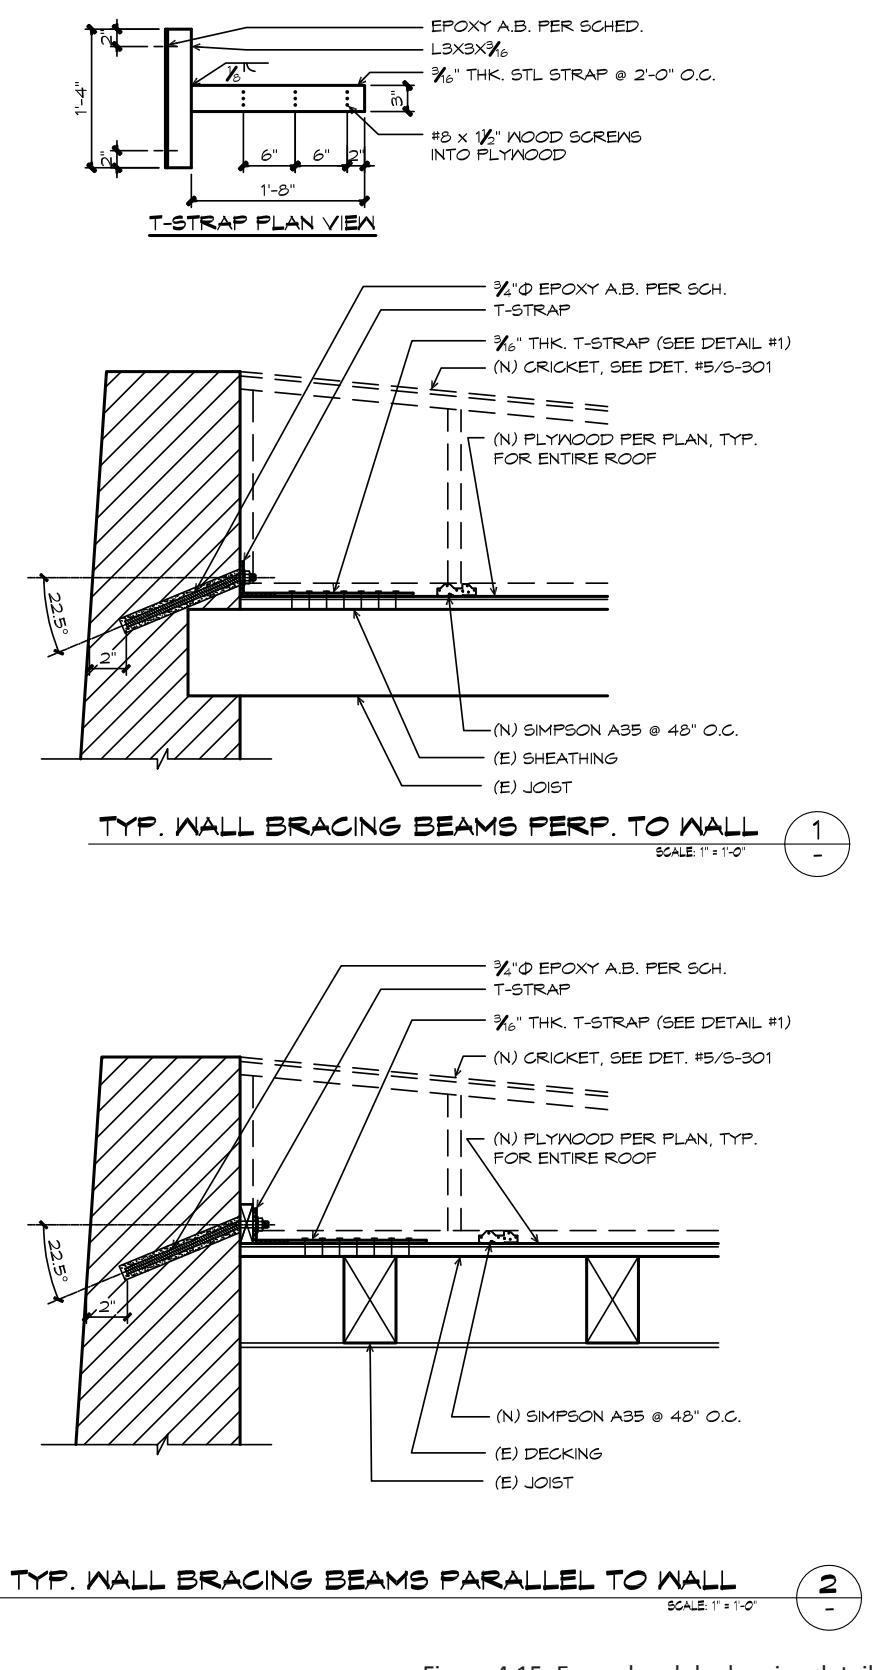
Figure 4.15: Example adobe bracing details SOURCE: Mel Green and Associates, Inc. Intentionally Blank Page

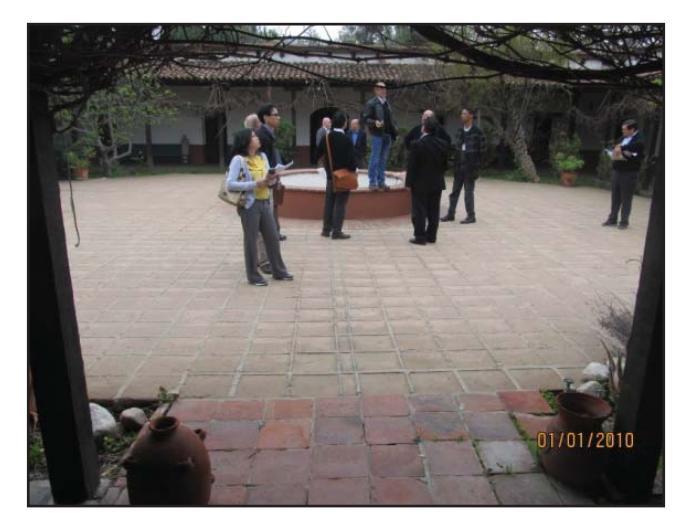
Figure 5.1: Courtyard with fountain focal point SOURCE: VCA Engineers, Inc.

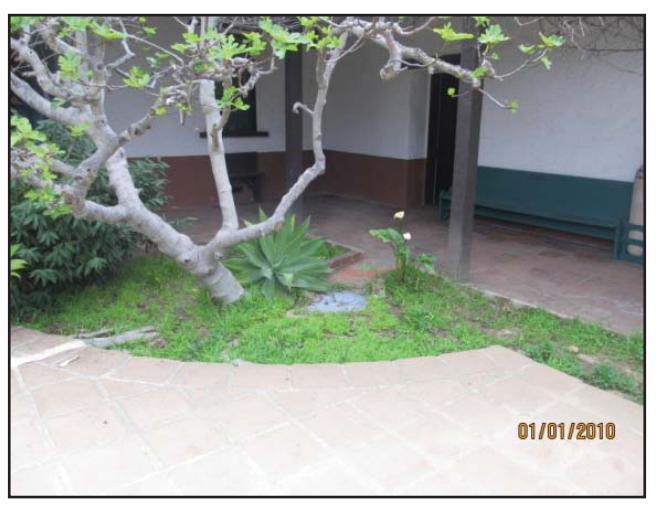
Figure 5.2: Landscape pocket SOURCE: VCA Engineers, Inc.

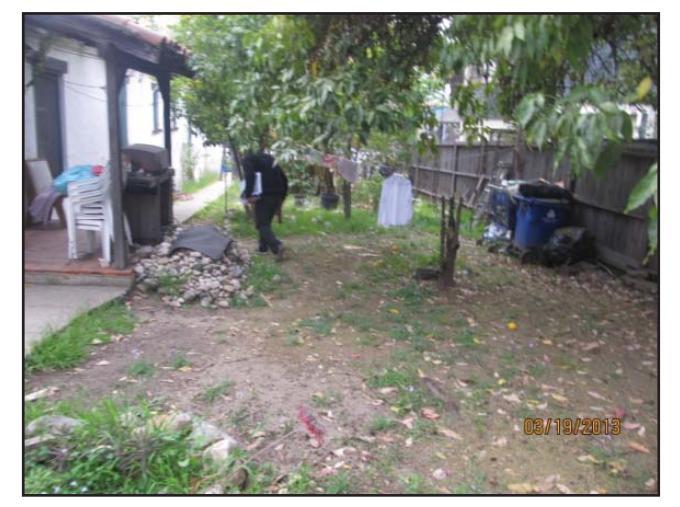
Figure 5.7 SOURCE: VCA Engineers, Inc.

At the southwestern edge of the property, near the southern corner, is a short free standing wall extending from the adjacent property to the outside edge of the exterior walkway running along the existing main building. Along this exterior walkway moving from the southern corner to the western corner of the existing building the walkway is interrupted by a porch cover coming off the face of the main building at its western corner. Within this portion of the property contains the densest portion of landscape and garden features and a wall separating the southwest edge of the property from the back portion of the property. Figures 5.7, and 5.8 depict the landscape garden area at the southwest edge of the property.

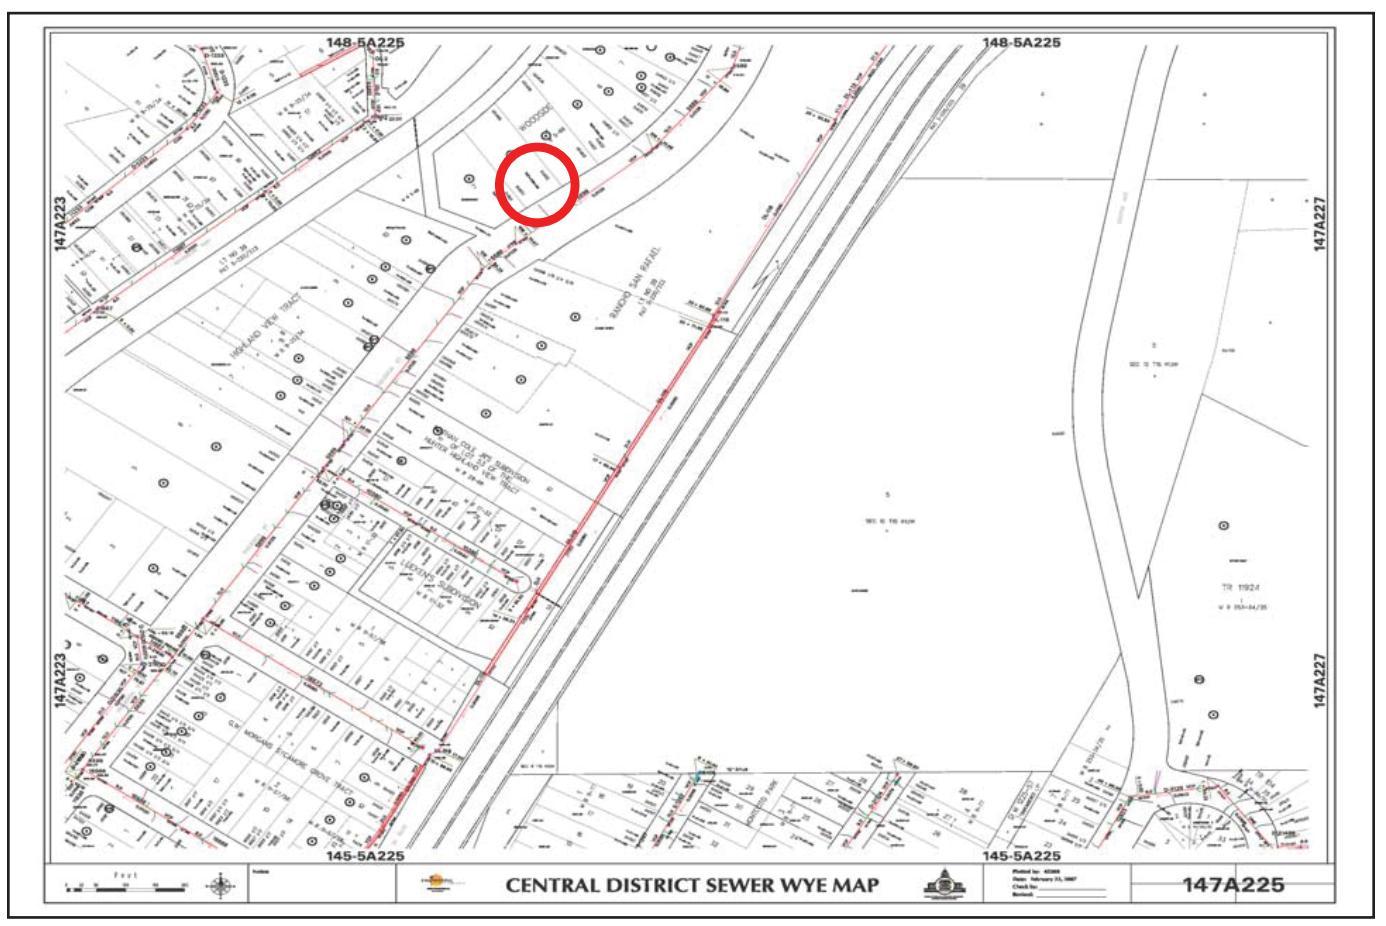
Per City of Los Angeles Bureau of Engineering Central District Sewer Wye Map, see Figure 5.15, it is determined that the Casa de Adobe Museum has an existing house connection to the existing sewer main line along Figueroa Street. It is also determined that the house connection is active to serve the needs of the museum caretaker.

Without having the as-built information for the on site sanitary sewer system, it is determined from field investigation that the sewer system runs parallel to the southwest building face and meets the house connection at the property line where indicated on the Sewer Wye Map. This was the conclusion due to an exposed joint near midway the southwestern building face showing the vitrified clay pipe. The exposed portion of the pipe also shown a collapsed portion of the pipe. No other indication of on site sanitary sewer lines was discovered.

Figure 5.15: Sewer Wye Map. Casa De Adobe is within the red circle SOURCE: VCA Engineers, Inc.

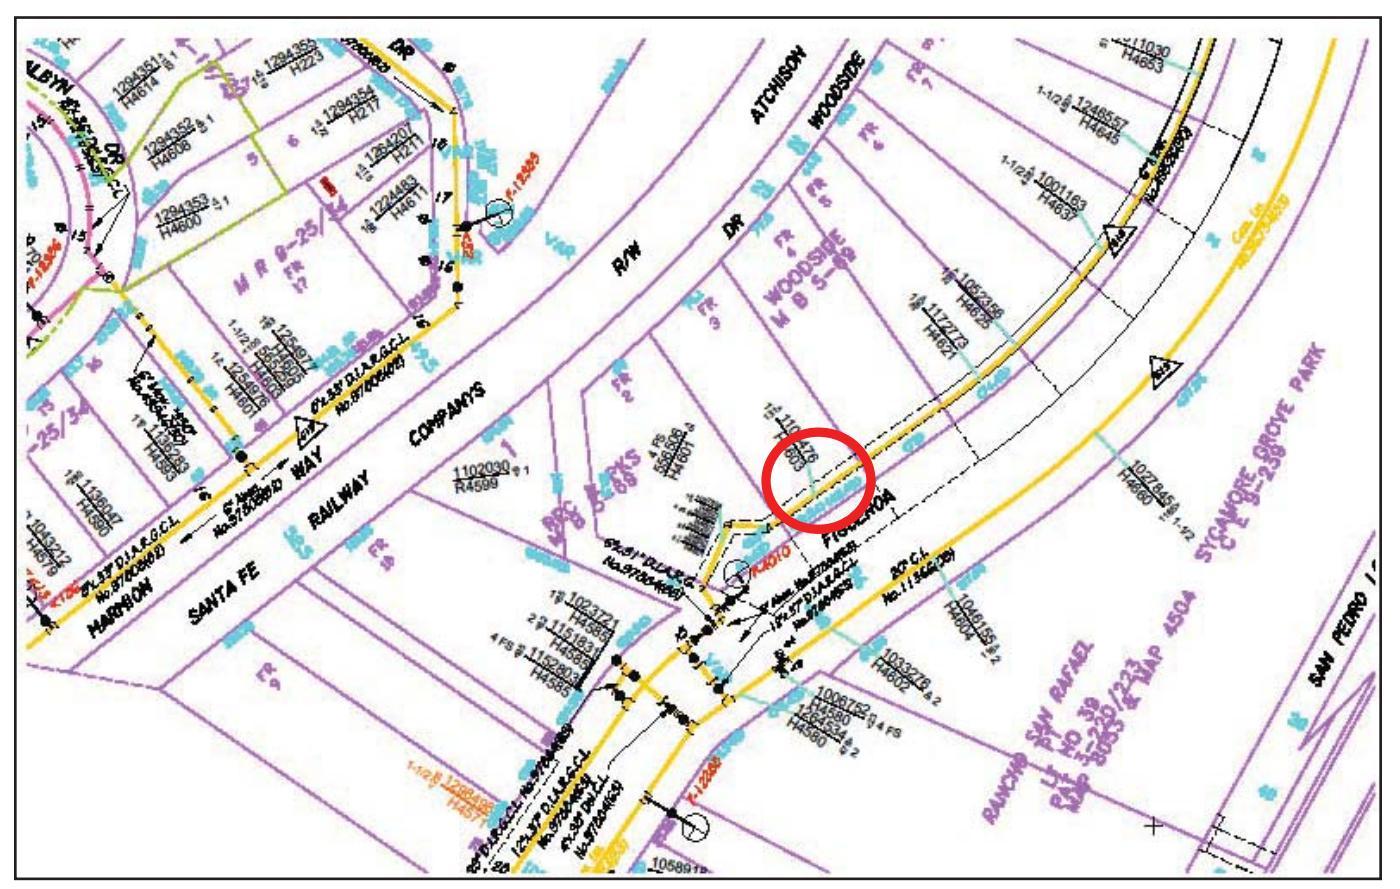
Per Los Angeles Department of Water and Power water distribution maps, see Figure 5.16 for water map, it is determined that the Casa de Adobe Museum has an active metered connection near midway along the Figueroa Street property line. This connection to the main line services the demand of the museum, but it is not determined if the same connection is utilized for irrigation purposes.

Figure 5.16: LADWP Map. Casa de Adobe site is within the red circle SOURCE: VCA Engineers, Inc.
