CASA DE ADOBE HISTORIC STRUCTURE REPORT

DRAFT - APRIL 14, 2006

AUTRY NATIONAL CENTER'S SOUTHWEST MUSEUM OF THE AMERICAN INDIAN 234 Museum Drive Los Angeles, CA 90065

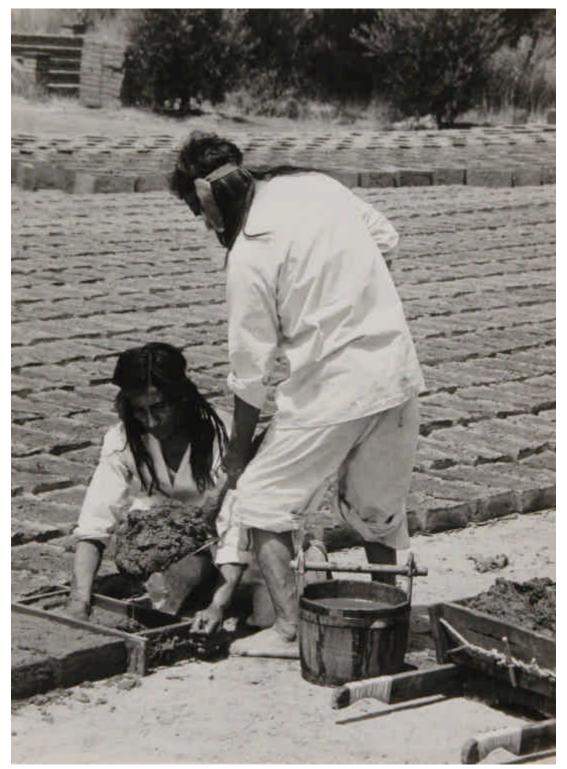
HP 1: Gabrielino Indians make adobe bricks for the Casa de Adobe, ca. 1916.

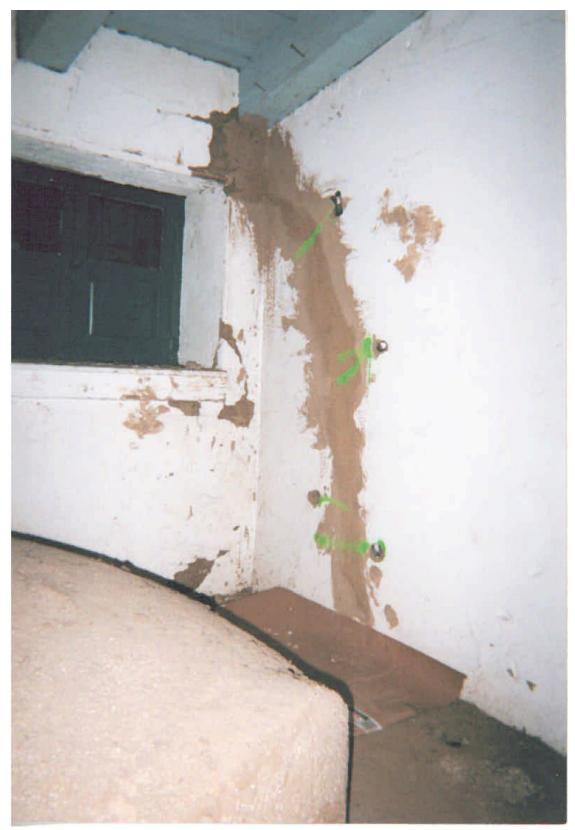
HP 23: Stitch anchoring at the northeast corner of the Horno, 1998.

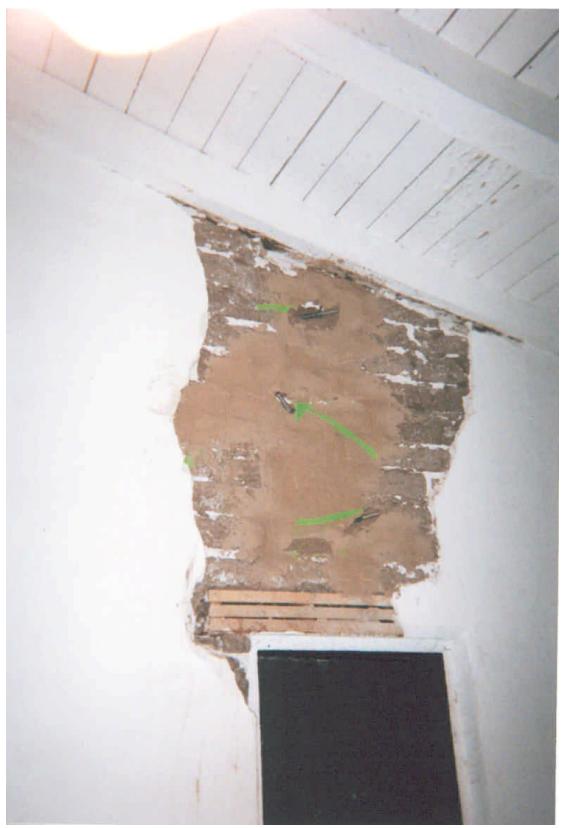
HP 24: Stitch anchoring at Sepúlveda Room., 1998.

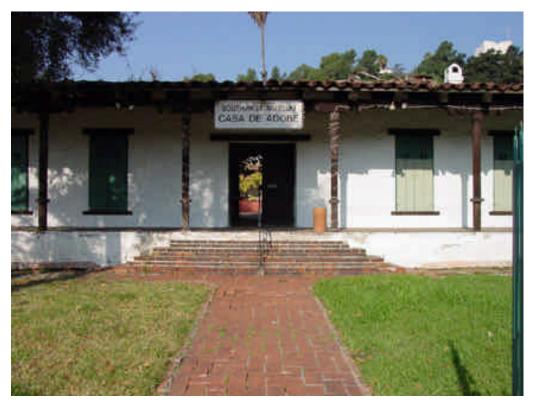
Photo 5: Original brick pathway and entry steps. The wrought iron railing was added ca. 1980s. 2005

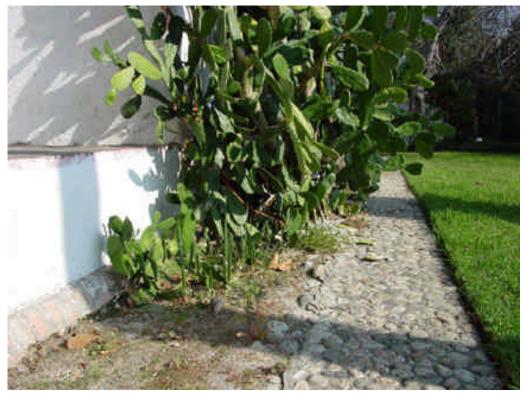
Photo 7: All landscaping should be relocated 5-10 feet away from the adobe building. The rock studded walkway is uneven and does not meet ADA requirements. 2005

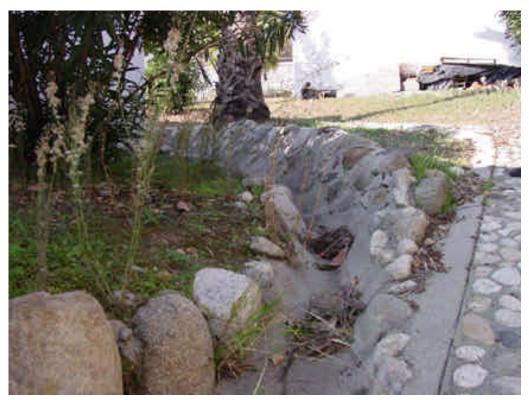
Photo 8: Perimeter drainage wraps around the northwest corner. 2005

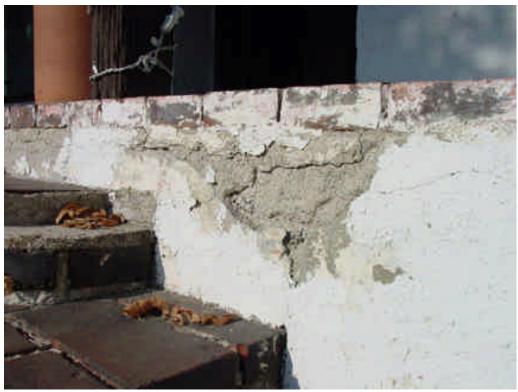
Photo 11: Plaster delamination at the entry porch base. 2005

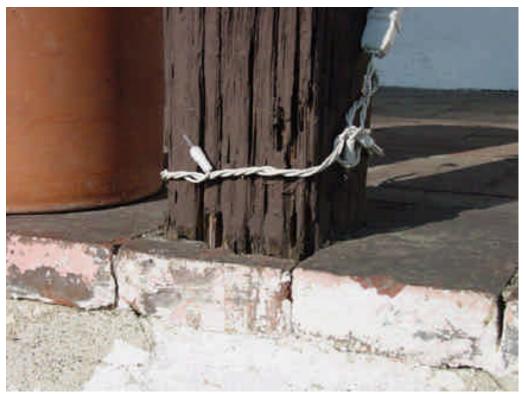
Photo 12: Dryrot at the base of the column at the entry porch. 2005

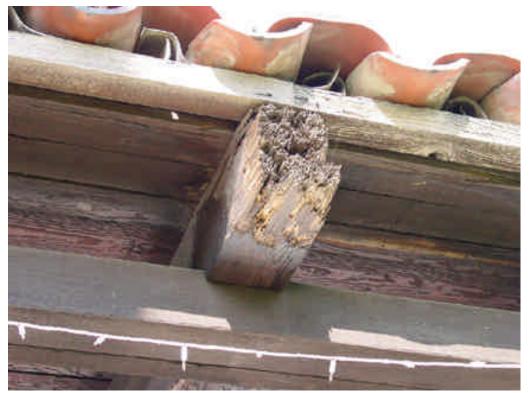
Photo 15: Rafter tail along the exterior east façade shows signs of dryrot. 2005.

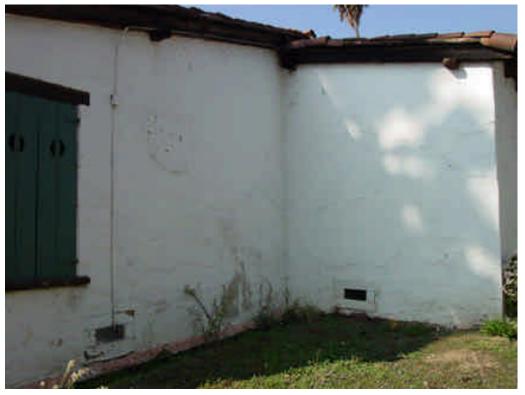
Photo 21: Northeast corner showing plaster patching, exposed conduit, and crawlspace vents. 2005

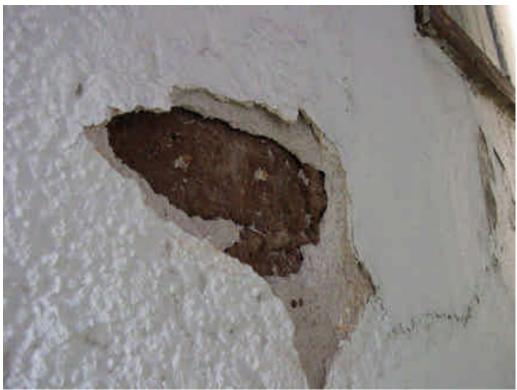
The existing "U" shaped adobe structure and inner courtyard is a premiere character-defining feature to the Casa de Adobe historic site. The building is located in its original configuration and at its original site of construction. The existing historic adobe masonry at the Casa de Adobe is a premiere character-defining feature. The Casa was built utilizing over 60,000 adobe bricks measuring 2 feet by 2-1/2 feet thick. (Refer to Photos HP1-HP3) Historically, adobe bricks were frequently made from clay found close to the site, as at the Casa de Adobe. After the bricks were dried, they were laid with adobe mud. Frequently the mud contained shards of rock and debris from the site. Therefore, in addition to being a character-defining feature, the adobe may contain material that could yield important archaeological information about the site. Cement and lime plaster was added during the initial construction of the adobe building and repaired in 1954. (Refer to Photo 22)

Photo 22: Detail of plaster delamination and exposed adobe. 2005

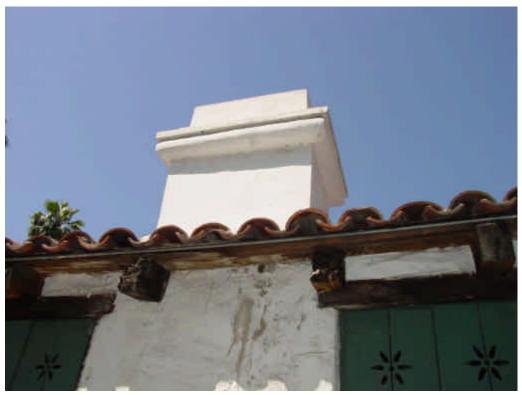
Photo 23: Kitchen chimney. 2005

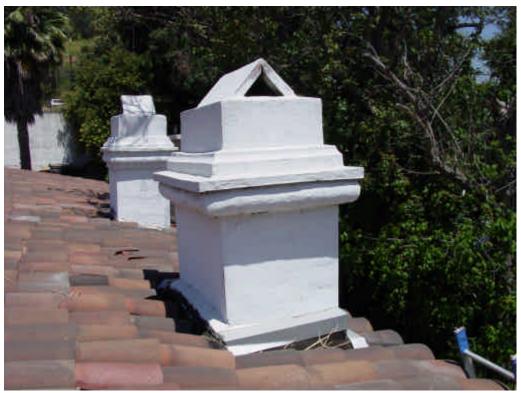
Photo 24: Kitchen and Horno chimneys. 2005

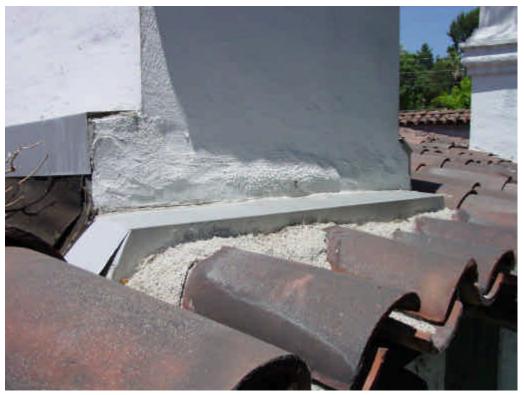
Photo 25: Horno chimney flashing detail. 2005

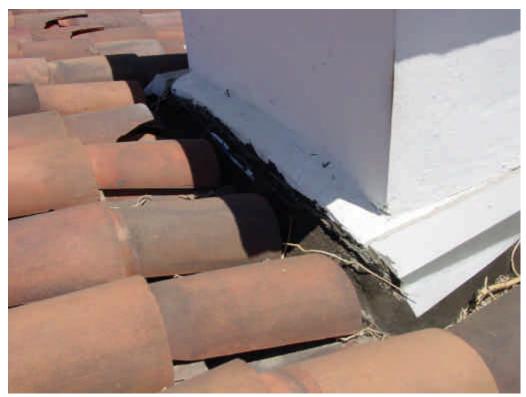
Photo 26: Kitchen chimney flashing detail. 2005

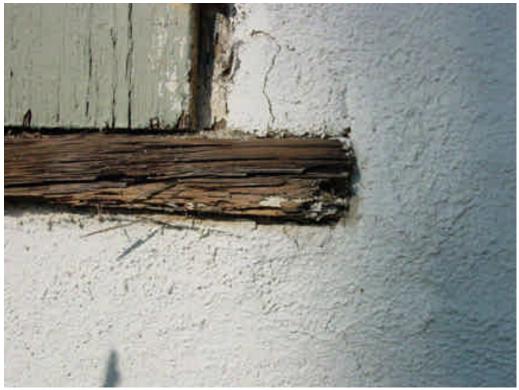
Photo 27: Window sill dryrot. 2005

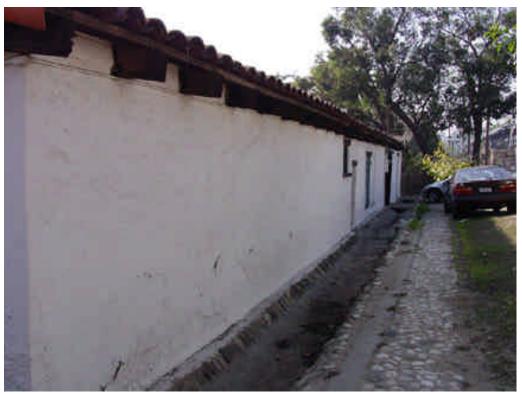
Photo 28: Plaster delamination at west façade. 2005

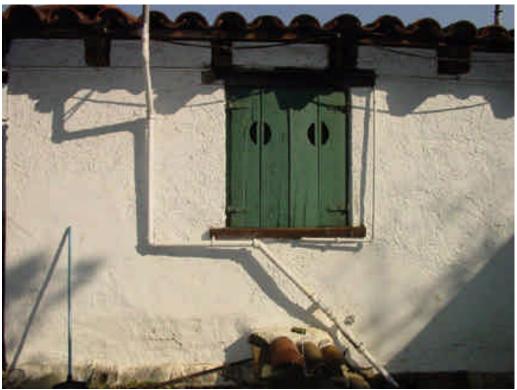
Photo 32: Exposed piping at southwest facade. 2005

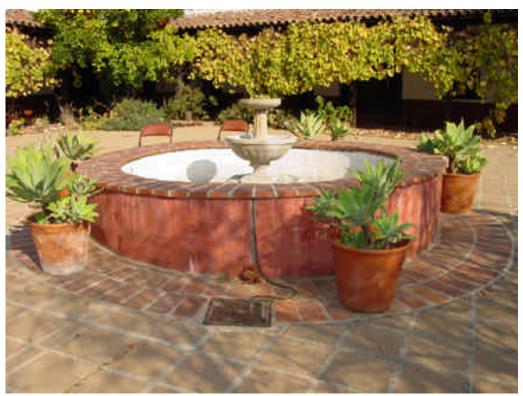
Photo 40: Drain detail at fountain. 2005

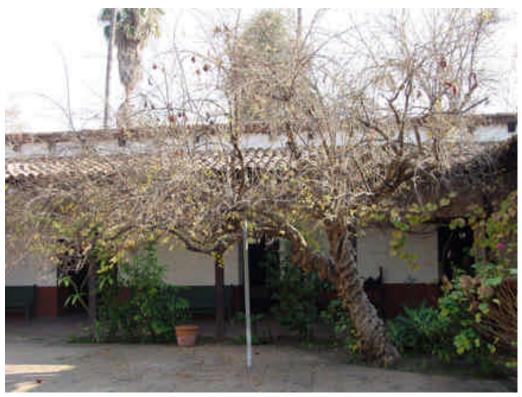
Photo 44: Historic pomegranate tree at southwest courtyard. 2005

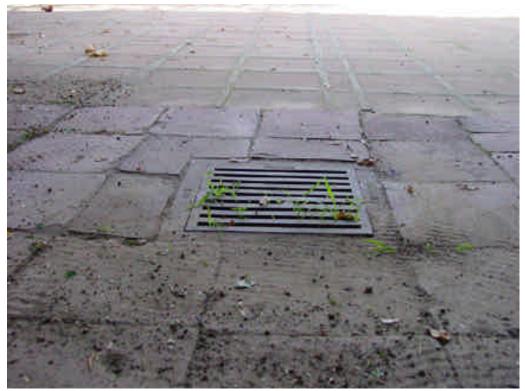
Photo 47: Drainage detail and original tile flooring at west porch area. 2005

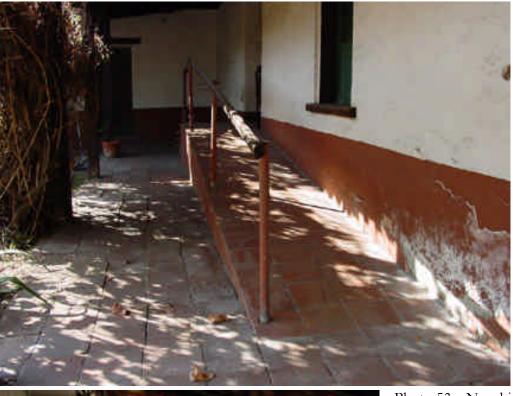
Photo 53: Non-historic ramp does not comply with ADA. 2005

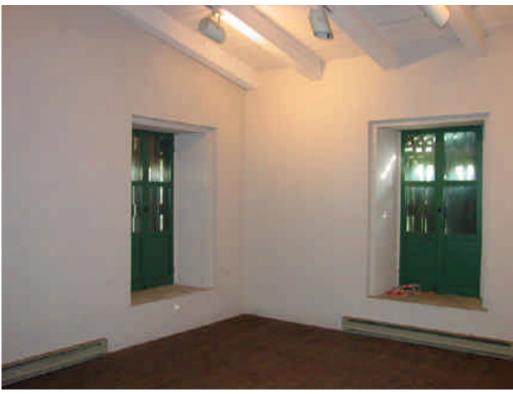
Photo 57: Furred-out walls and baseboard heaters in Music Room/Gallery. 2005

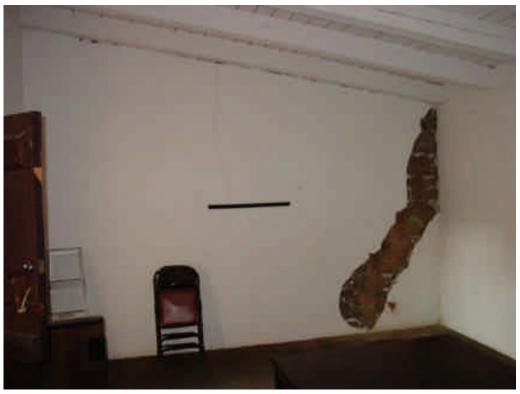
Three steps leads to the Dining Room's *(Comedor)* vertical plank door. The door has its original hardware. A non-historic dead bolt has been added above the pulley for additional security. The floor is wood plank. Three typical windows occupy this room. Two are exterior facing at the north wall and one faces the veranda at the south wall. The south wall window faces the veranda and does not contain the wood grate or shutters as those found on the north wall. The wooden ceiling is painted white. All features in this room are considered premiere character-defining. (Refer to Photo 58 and HP 15)

Photo 58: Dining Room looking west showing delaminated plaster and exposed adobe. 2005

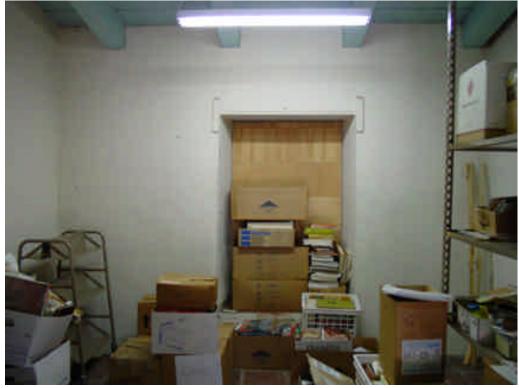
Photo 71: The Museum Room is now used for storage. Boarded up window along the west wall. 2005

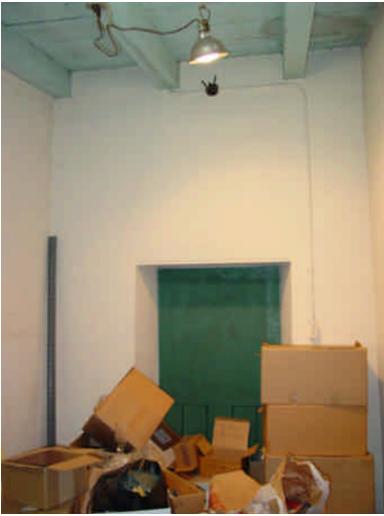
Photo 72: Museum Room showing unhistoric flood lights and exposed conduits. The east wall window is boarded up. 2005

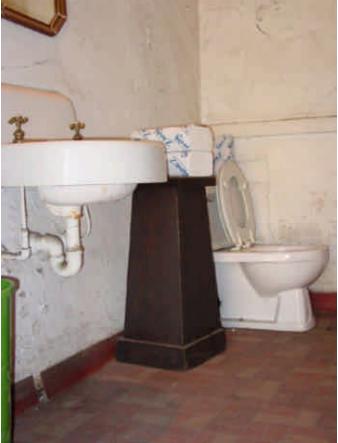
Photo 85: The original Lavatory now utilized as Men's Restroom. The restroom does not meet ADA requirements. 2005

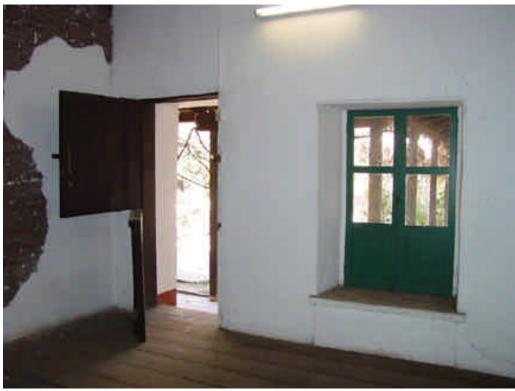
Photo 90: Delaminated plaster and exposed adobe at east wall of Children's Room. 2005
