# Southwest Museum Rehabilitation Study

## Phase I Planning

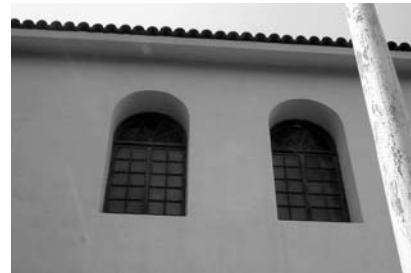
**HR004** - South elevation of main building; original windows at West End

Many windows of the Main Building are original, although about half have been replaced. The original window materials consist of wood framed multi-light casement windows with lunettes above each. Replacement windows are single-paned and set in aluminum frames. On the north elevation of the Main Building window materials were removed during an alteration in 1938, and the openings were filled in with concrete and coated with exterior finish. While many of the Main Building's window materials have been replaced, window openings on each elevation are significant. (See photos HR004 and HR005)

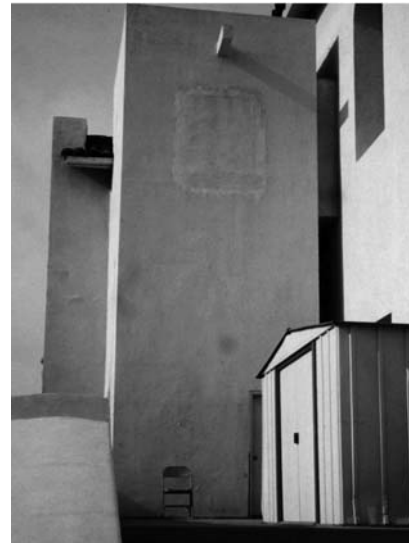
HR016 - Elevator shaft tower; east side, showing filled-in window opening

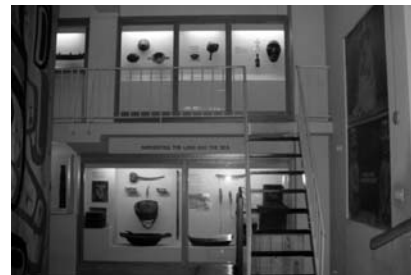
HR022 - Northwest Hall (Caracol 5)

The exhibit spaces of Caracol 4 and Caracol 5 have some similar character-defining features. Both have original doorways leading to the Caracol stair, but the original door materials themselves have been replaced. The doorway and door materials leading into Caracol 5 from Plains Hall, however, are completely original, including the door hardware. Whereas the walls and ceilings of these exhibit spaces are original, excluding applied decoration, the exhibit cases and lighting have been replaced and are therefore not significant. The flooring of these exhibit spaces has been carpeted, and therefore is not significant. (See photo HR022).

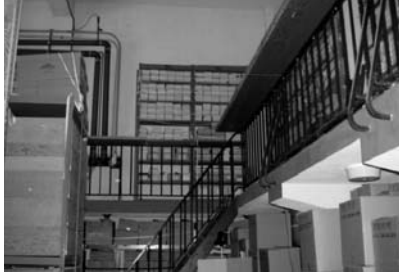
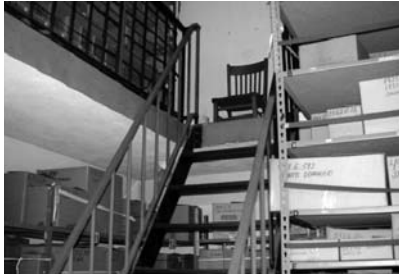
Caracol 6 and Caracol 7 share similar features despite their different intended functions. Most notable are their mezzanines, which are similar to the mezzanine of Northwest Hall, but run around all four outer walls. In both mezzanines, a wood ledge has been added above the rails and is not significant. (See photos HR023 and HR024).

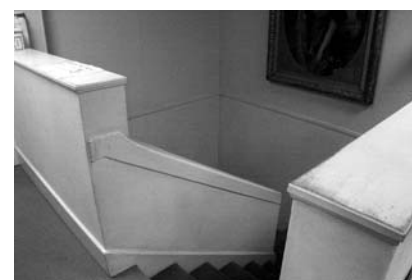
HR028 - Open stair from level one offices to basement

The basement of Torrance Tower is reached by a staircase that retains its original design and materials, other than its steps which have been carpeted. The walls of the stair are solid. The stair leads to a hallway, with a door at the opposite end, and before the door storage and office areas. At the base of the stair and under the stairs themselves, there is an office addition with hollow walls and a doorway. None of the materials of this addition are original. (See Photo HR028).

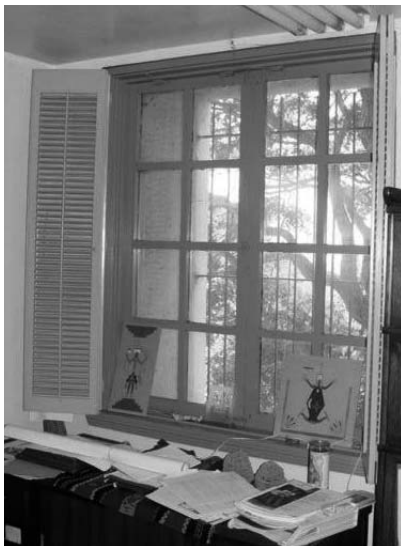
On one side of the hallway is a storage area that retains no original features and therefore is not significant. On the other side of the hallway, two offices exist with historic door and window openings and materials, baseboards, and built-in wood cabinets. The windows are rectangular, wood framed, multi-light casement windows. The doors are paneled wood doors and have original hardware. The existing chair rail along portions of the wall of the southern-most office is original. The floors have been covered with resilient tiles but the original scored-concrete flooring may remain below. Parts of the baseboard have been covered with a flexible cove base material. (See photos HR029 and HR030).

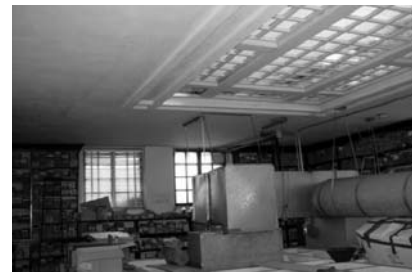
**HR035** - Torrance Tower: false skylight below; historic skylight above

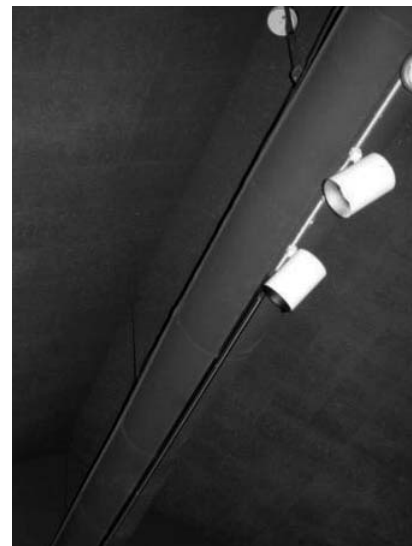
**HR039** - Poole Wing: original ceiling with added lighting & duct

NOT SIGNIFICANT

- The existing, exposed duct will be replaced with a new, oval duct. A lighting trough, similar to that shown in the original architectural drawings, will be installed below it.

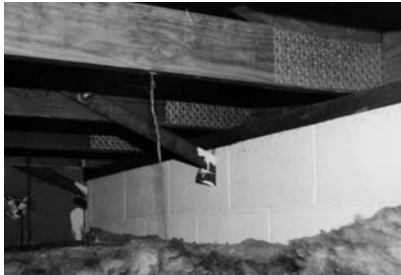
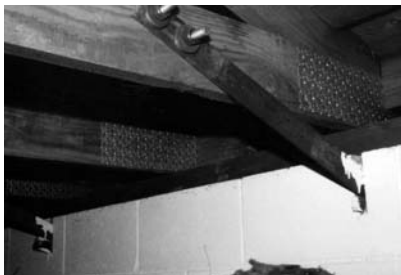
**S005** - Braun Library - Connection of roofing diaphragm to wall

**S006** - Braun Library: roof connection detail

The lateral force resisting system is provided by the stiffness of the exterior reinforced masonry shear walls in both the longitudinal and transverse directions. The plywood sheathing at the roof and concrete topping at the elevated floors function as load distributing horizontal diaphragms. The transfer of lateral loads from the roof diaphragm to the walls is accomplished by nailing the sheathing to continuous wood nailers bolted to the tops of the walls. The transfer of lateral loads from the floor diaphragm to the walls is accomplished by dowels. The transfer of lateral loads from the walls to the foundation system is also accomplished by dowels. Positive wall anchorage between the walls and roof framing was detailed on the plans and observed during the site visits (*see photos S005 and S006*). This connection is not adequate for the expected loads and repair is proposed.

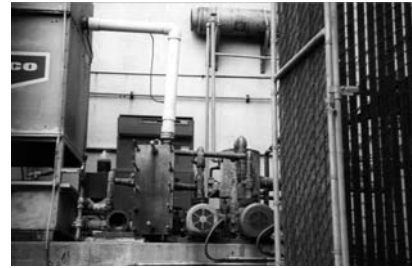
**M001** - Main building mechanical equipment south of Caracol Tower

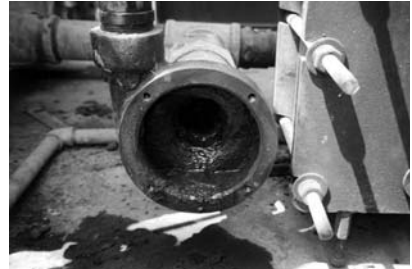
**M002** - Back-up pump removed for service

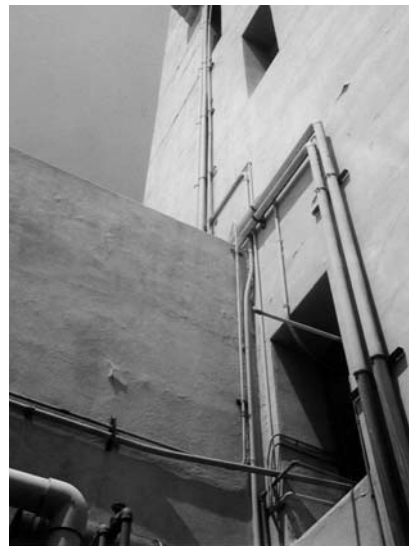
**M003** - Piping from condenser; south face of Caracol Tower

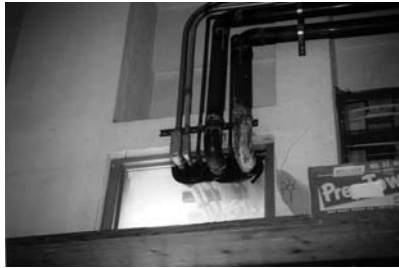
**M004** - Condenser piping enters Caracol Tower through window

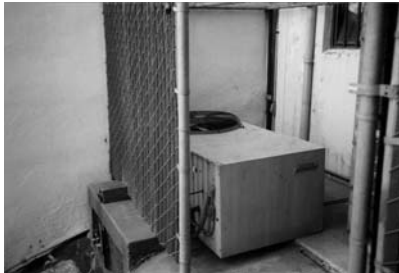
**M005** - Condenser at Poole Wing

Air conditioning for the upper level of this wing is provided by a split system, which is comprised of a nominal 4-ton condensing unit located on the East side of the wing (*See photo M005*) and an indoor fan coil unit located in the attic over the vestibule leading to the exhibit hall. Exposed ducts distribute air to the space. This equipment is approximately nineteen years old and has an expected service life of fifteen years. (*See photo M007*)

next to the basket storage. A duct mounted electric humidifier serves this system. A dust collection blower system located in the shed east of this building serves intake outlets serving the workbench in the workroom. This dust collection system appears to be in good condition. (See photos M005 and M007)

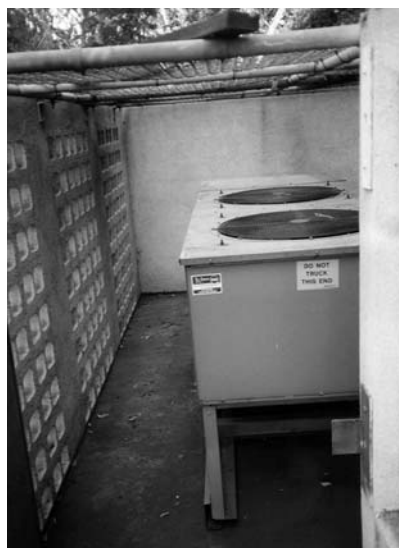
**M006** - Condensing unit serving Braun Library

The library is air conditioned by a 20 ton split air conditioning system comprised of a Carrier air cooled outdoor condensing unit (See photo M006) and a Trane air handling unit located in the attic. The air handling system has a gas-fired duct furnace providing re-heat and a duct humidifier by Auto-Flo. The major equipment appears to be in good condition. The condensing unit is approximately ten years old, not original and the air handling unit is approximately twenty five years old. There was some corrosion noted on the bottom of the duct furnace. (See photo M010). This could be from condensate blowing off the cooling coil, a result of an undersized coil, or as we were informed there was an ongoing roof leaking problem near this equipment which could account for the rusting. The air handling unit is very noisy at the third level and the unit essentially serves three levels using one zone, with the exception of a small reheat coil in a branch duct serving a small area of the Mezzanine. The ducts in the Braun Library should be insulated. According to data logs for the four-month period from April to August 2003, the temperature at the back wall generally ranged from 65° to 76° and humidity ranged from 40% to 60% RH. Data taken at the upper levels was similar however humidity levels were higher. The Time Weighted Preservation Index (TWPI) was indicated to be approximately forty years based on temperature and humidity readings logged during the four months from April to August 2003.

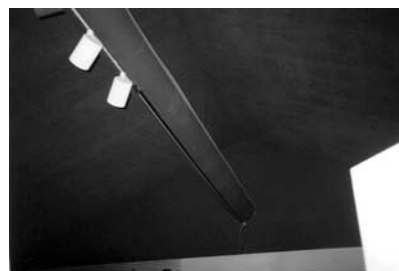
M007 - Exposed ducts in upper Poole Wing

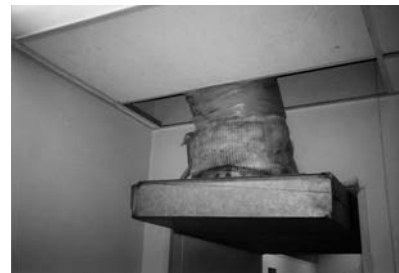
M008 - Duct from Torrance Tower to museum level one

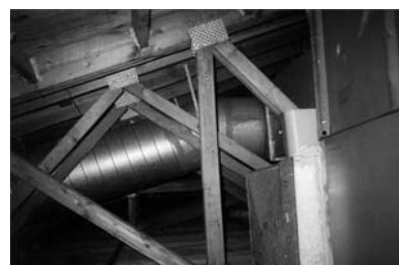
M009 - Uninsulated duct work in Braun Library

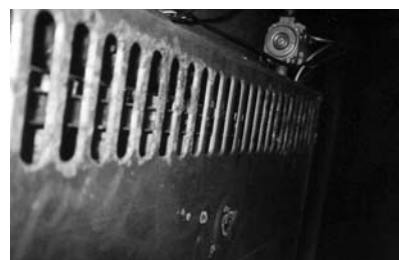
M010 - Duct furnace in Braun Library

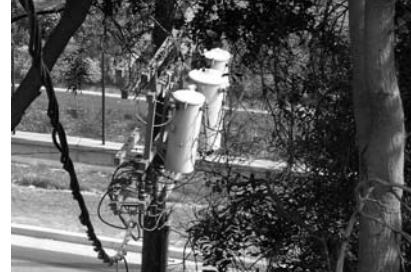
E001 - DWP utility pole on Marmion Way

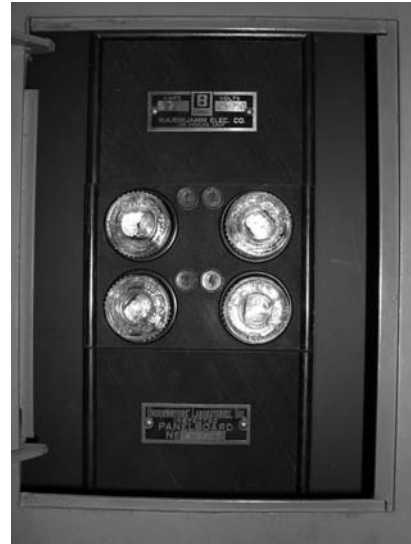
E002 - Boiler room fuse panel

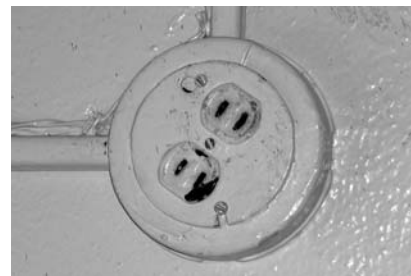
E003 - Ungrounded outlet, office area

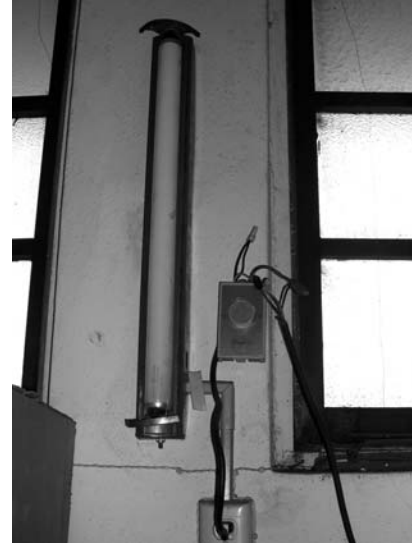
**E008** - Torrance Tower, illegal wiring for exhaust fan

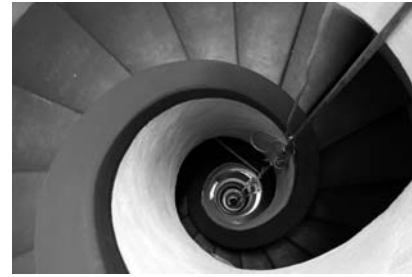
**E015** - Caracol Tower stair - exposed, unsupported conduit

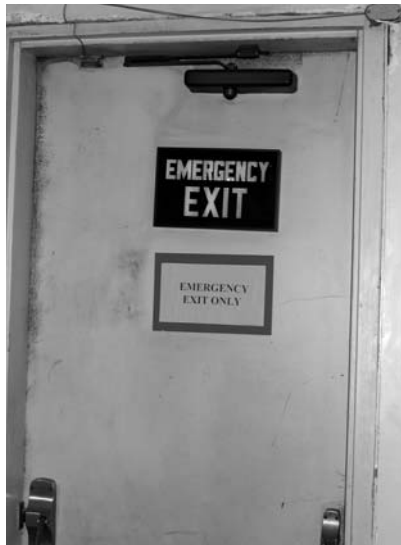
**E019** - Administration area exit lacking proper illumination and signage.

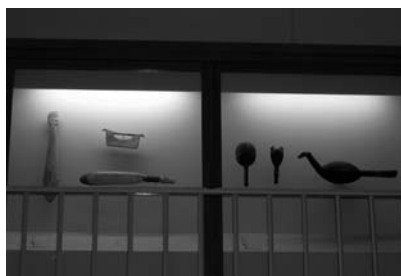
**E020** - Inconsistent display case lighting typical throughout

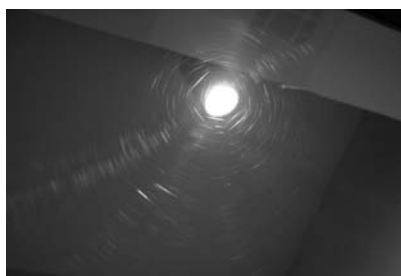
**E021** - Unprotected bare display case lighting emitting UV rays; typical throughout

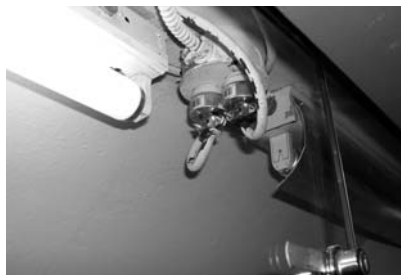
**E022** - Inconsistent display case lighting typical throughout

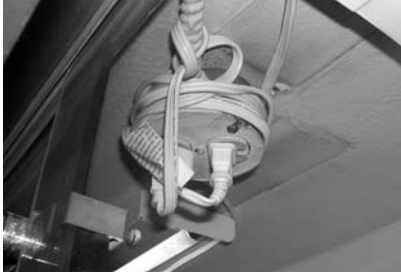
The bathrooms are illuminated with dated, energy-inefficient 2' x 4' fluorescent fixtures. The retail store has fluorescent display fixtures that are permanently wired to a receptacle. (See Photo E023)

**E023** - Extension cord used for permanent wiring in display case

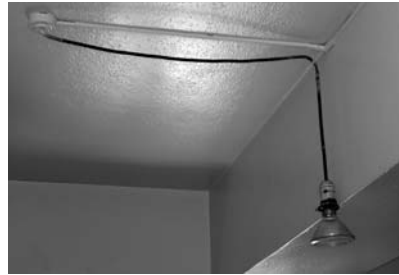
**E026** - Inefficient, out of date lighting in offices

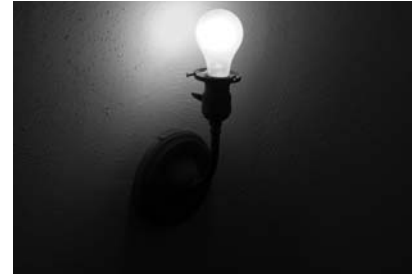
**E029** - Historic wall fixture typical in Caracol stair

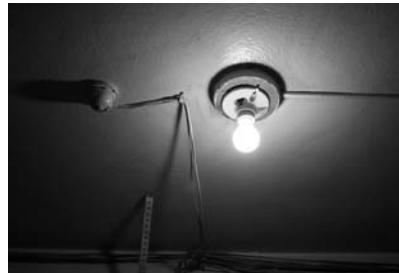
**E027** - Inefficient, out of date lighting in offices

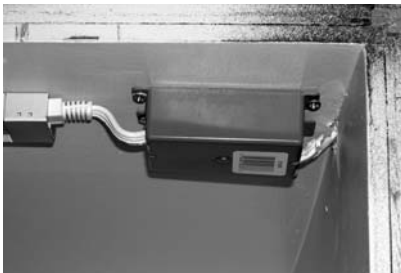
**E025** - Exposed junction box and Romex connectors in display case

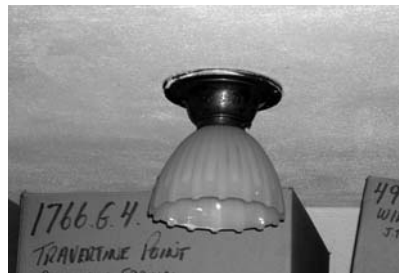
**E028** - Historic ceiling fixture typical in Caracol 6 & 7

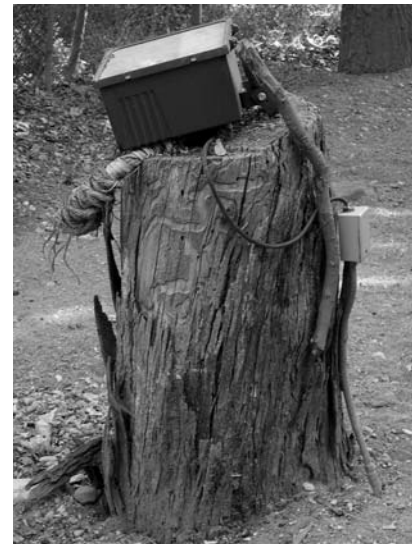
**E030** - De-activated exterior flood light at Caracol Tower

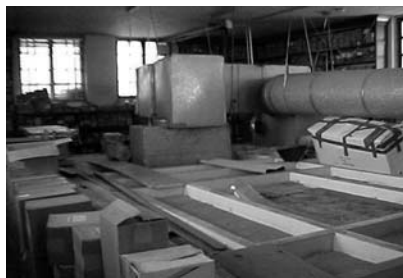
LS001 - Torrance Tower - Upper Mezzanine

The upper level mezzanine, with an approximate area of 680 square feet exceeds the maximum allowable area of 500 square feet permitted by code. It is our understanding that a request to allow the mezzanine of a size larger than the area permitted by code was previously submitted and approved. (See Photo LS001)

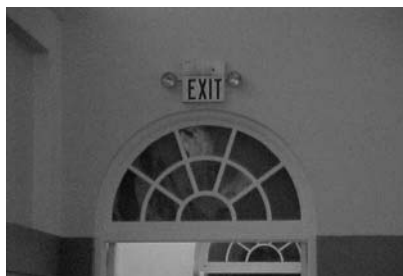
In several locations throughout the project, exit signs are not illuminated. (See Photo LS002). All exit signs are required to be illuminated at all times. Exit signs may be internally or externally illuminated.

LS002 - Typical non-illuminated exit sign

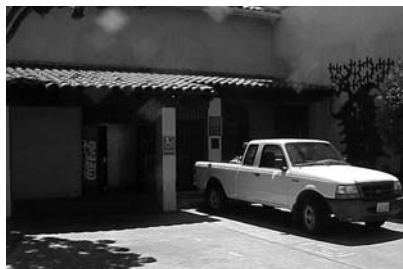
LS006 - Single, accessible stall;  
non-compliant
